September 3, 2013

Agency for Natural Resources and Energy, METI of Japan

2<sup>nd</sup> Fact sheet: Overview of Contaminated Water Issue at TEPCO's Fukushima Daiichi NPS

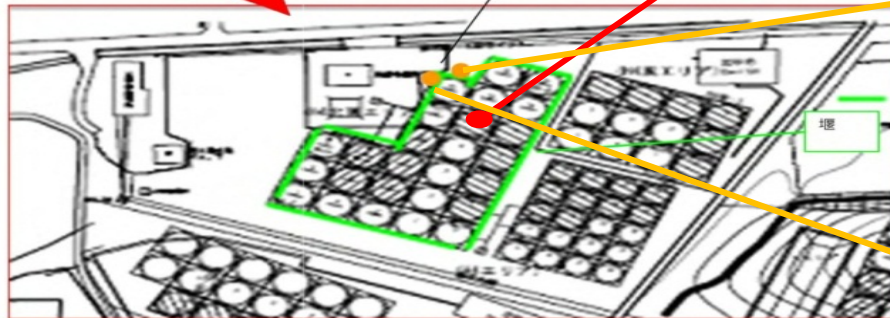
No. 5 tank

The place where paddles were found

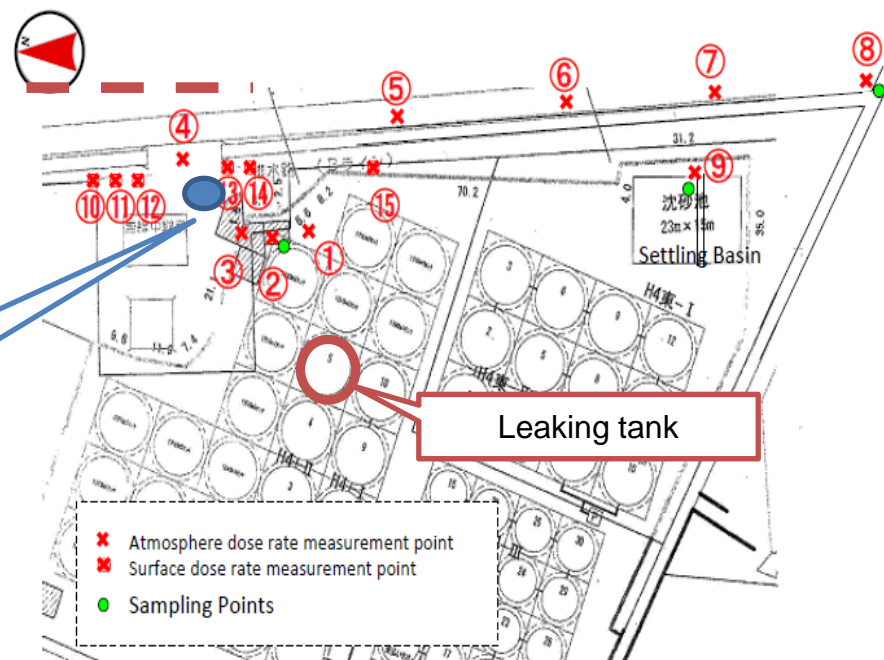
5.8 mSv was detected at the dike (on August 21)
