Comprehensive Risk Review of all the possible risks which might have an impact outside the site boundary of the Fukushima Daiichi Nuclear Power Station

~ Result of Comprehensive Risk Review ~

April 28, 2015

Tokyo Electric Power Company

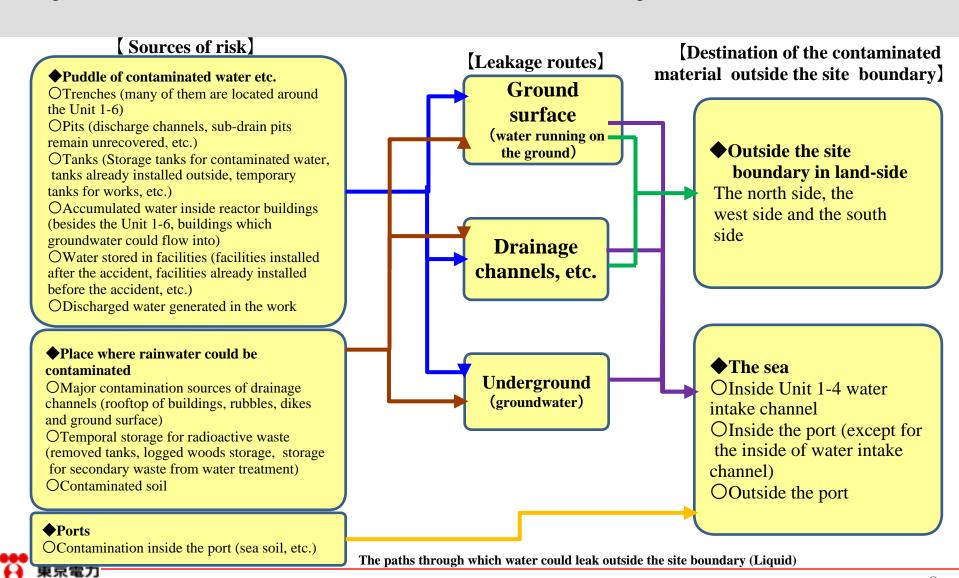
3-3. Identification of the target items (evaluation of the leakage path)

nDuring the identification of target items, paths leading to leakage outside the site boundary were identified taking into account the location of the risk sources and the assumed leakage of these sources.

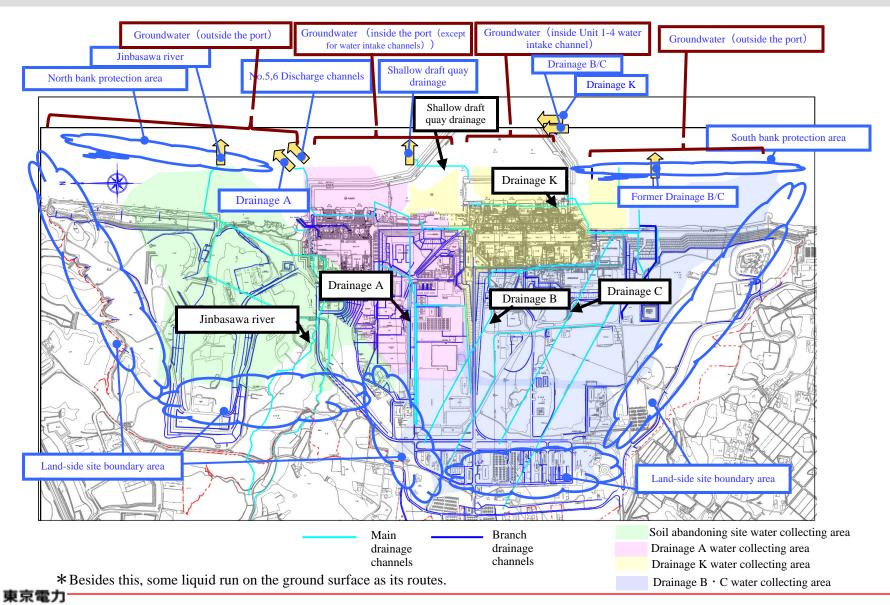
3-3. Identification of the target items (evaluation of the leakage path)

nFor the leakage paths, drains around the site were also examined based on field verification.

For the drains and clay pipes leading from within the site to outside the site, around the site boundary, the location of the drains and clay pipes was identified through investigation on site, and was incorporated into the classification results as the leakage path of rainwater.
