Response to Detection of Radioactive Materials Exceeding the Notification Level of Radioactive Concentration from Groundwater Near the Seawall

Tokyo Electric Power Company

November 26, 2013

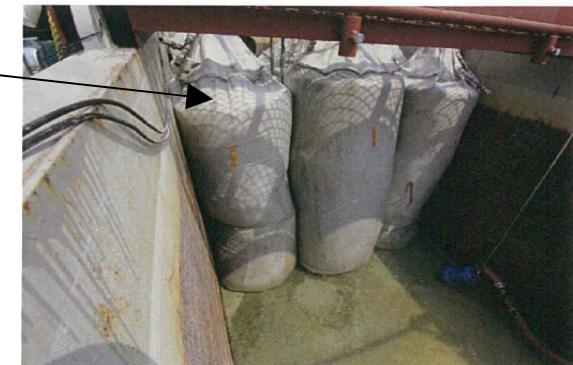
Photo image of packer

*Packer is a freezing duct wrapped with nylon cloth

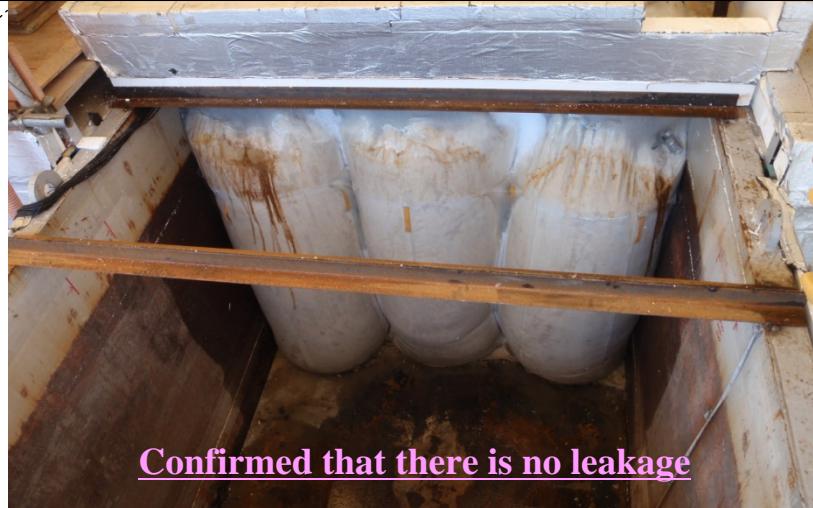
Checking of water blocking CASE1 (photo 10/12)

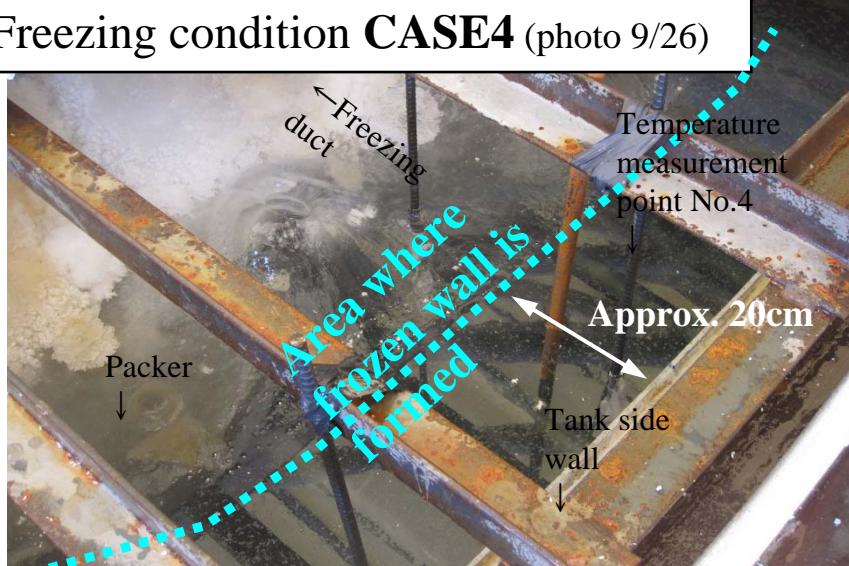
Freezing condition CASE4 (photo 9/26)

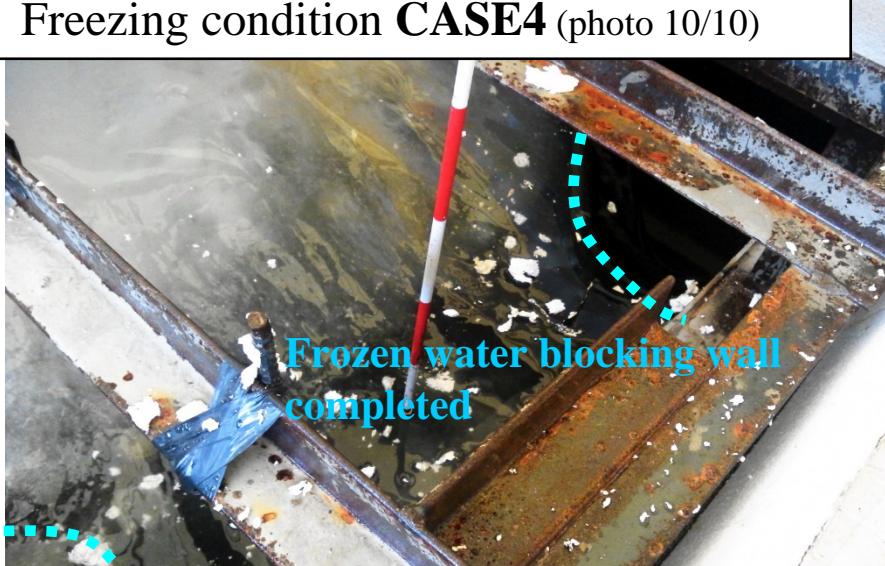
Freezing condition CASE4 (photo 10/10)
