# Application of complementary beam techniques to study deformation mechanisms in heterogeneous materials for automotive industry

M. Schöbel<sup>1,2</sup>, J. Bernardi<sup>3</sup>, R. Koos<sup>1</sup>

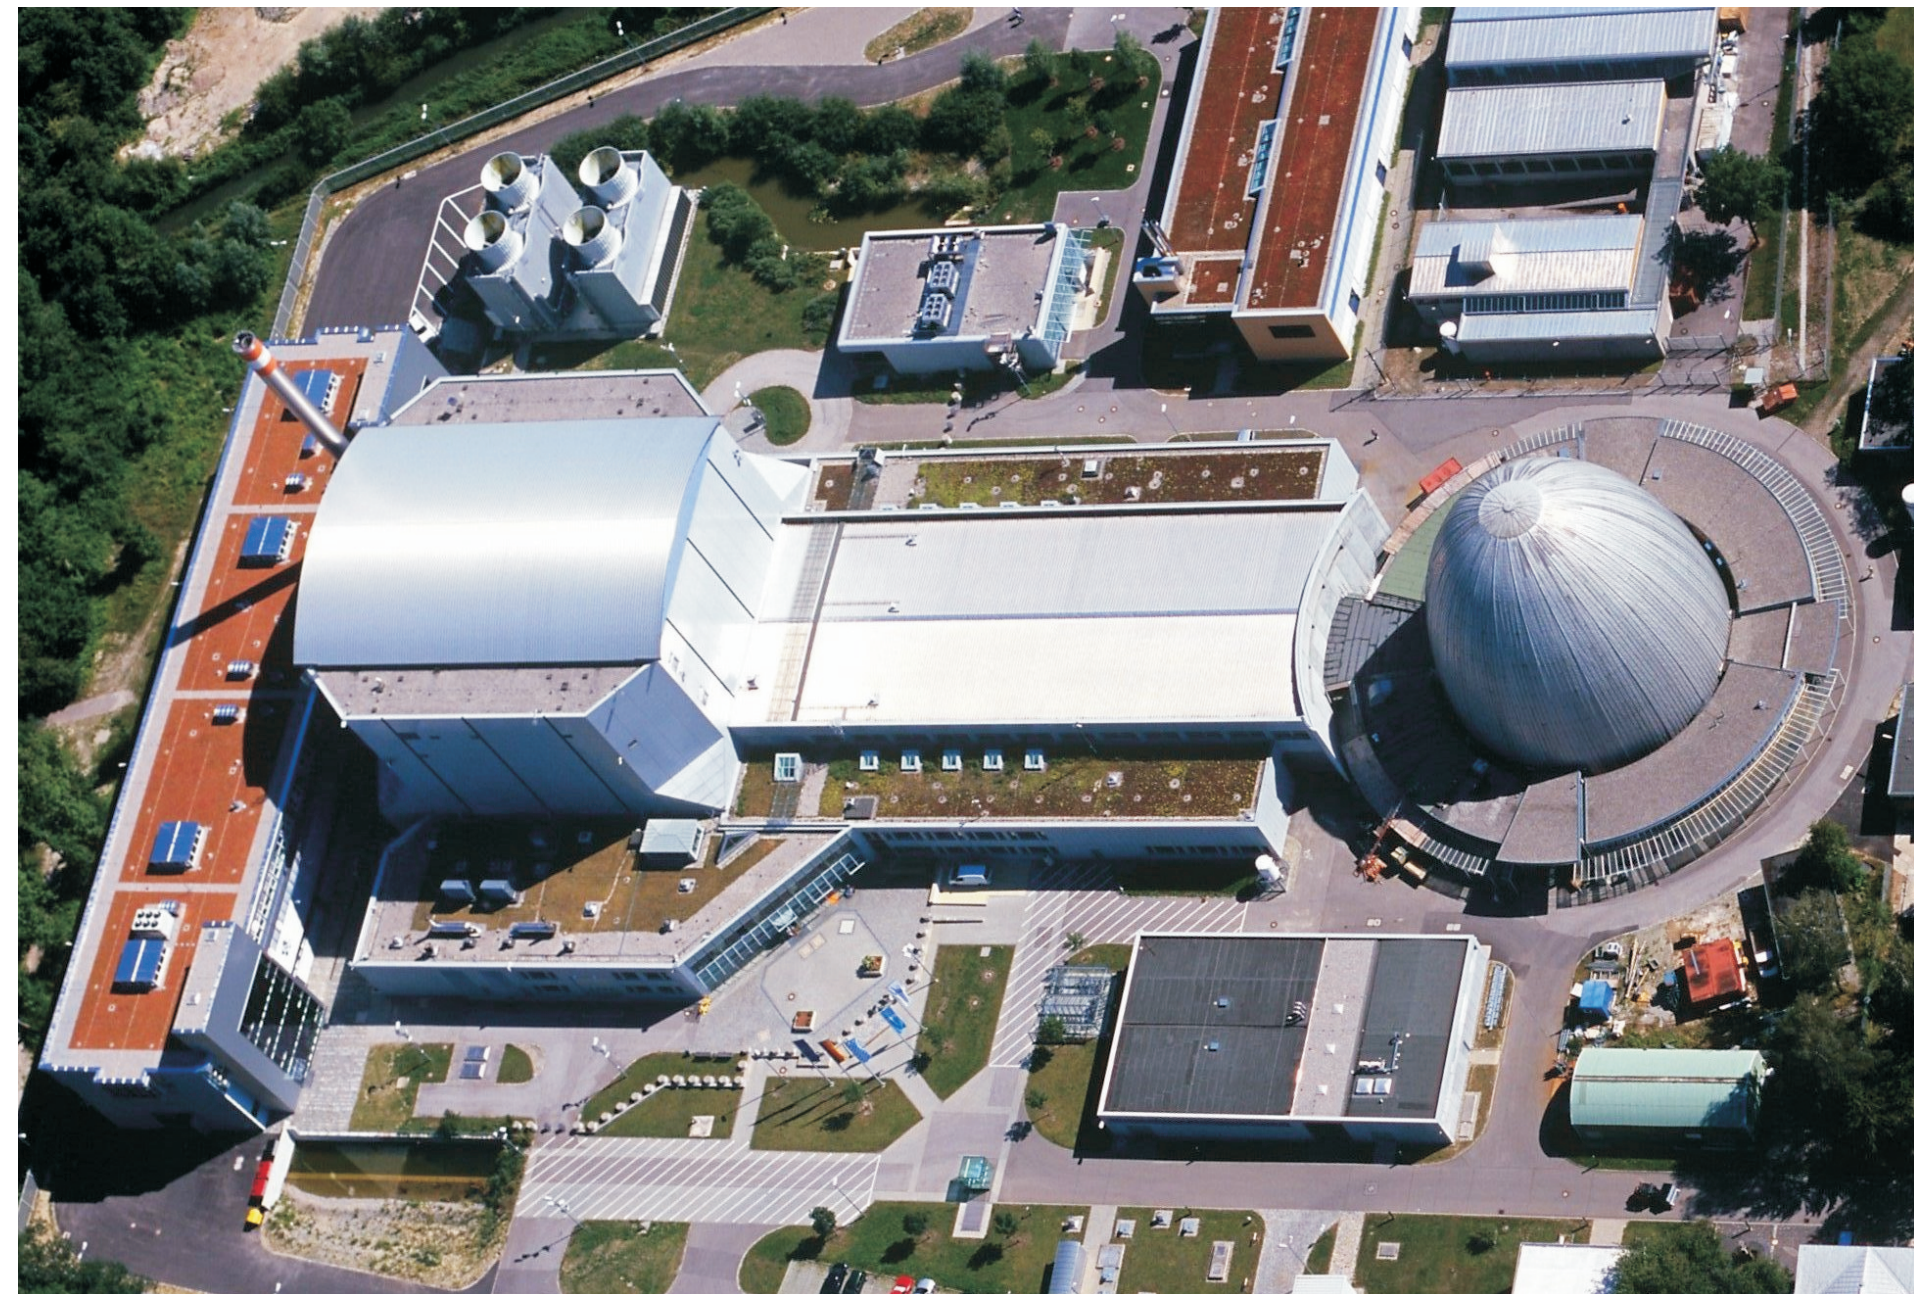
FRM2, high flux, continuous neutron source at Garching in Germany

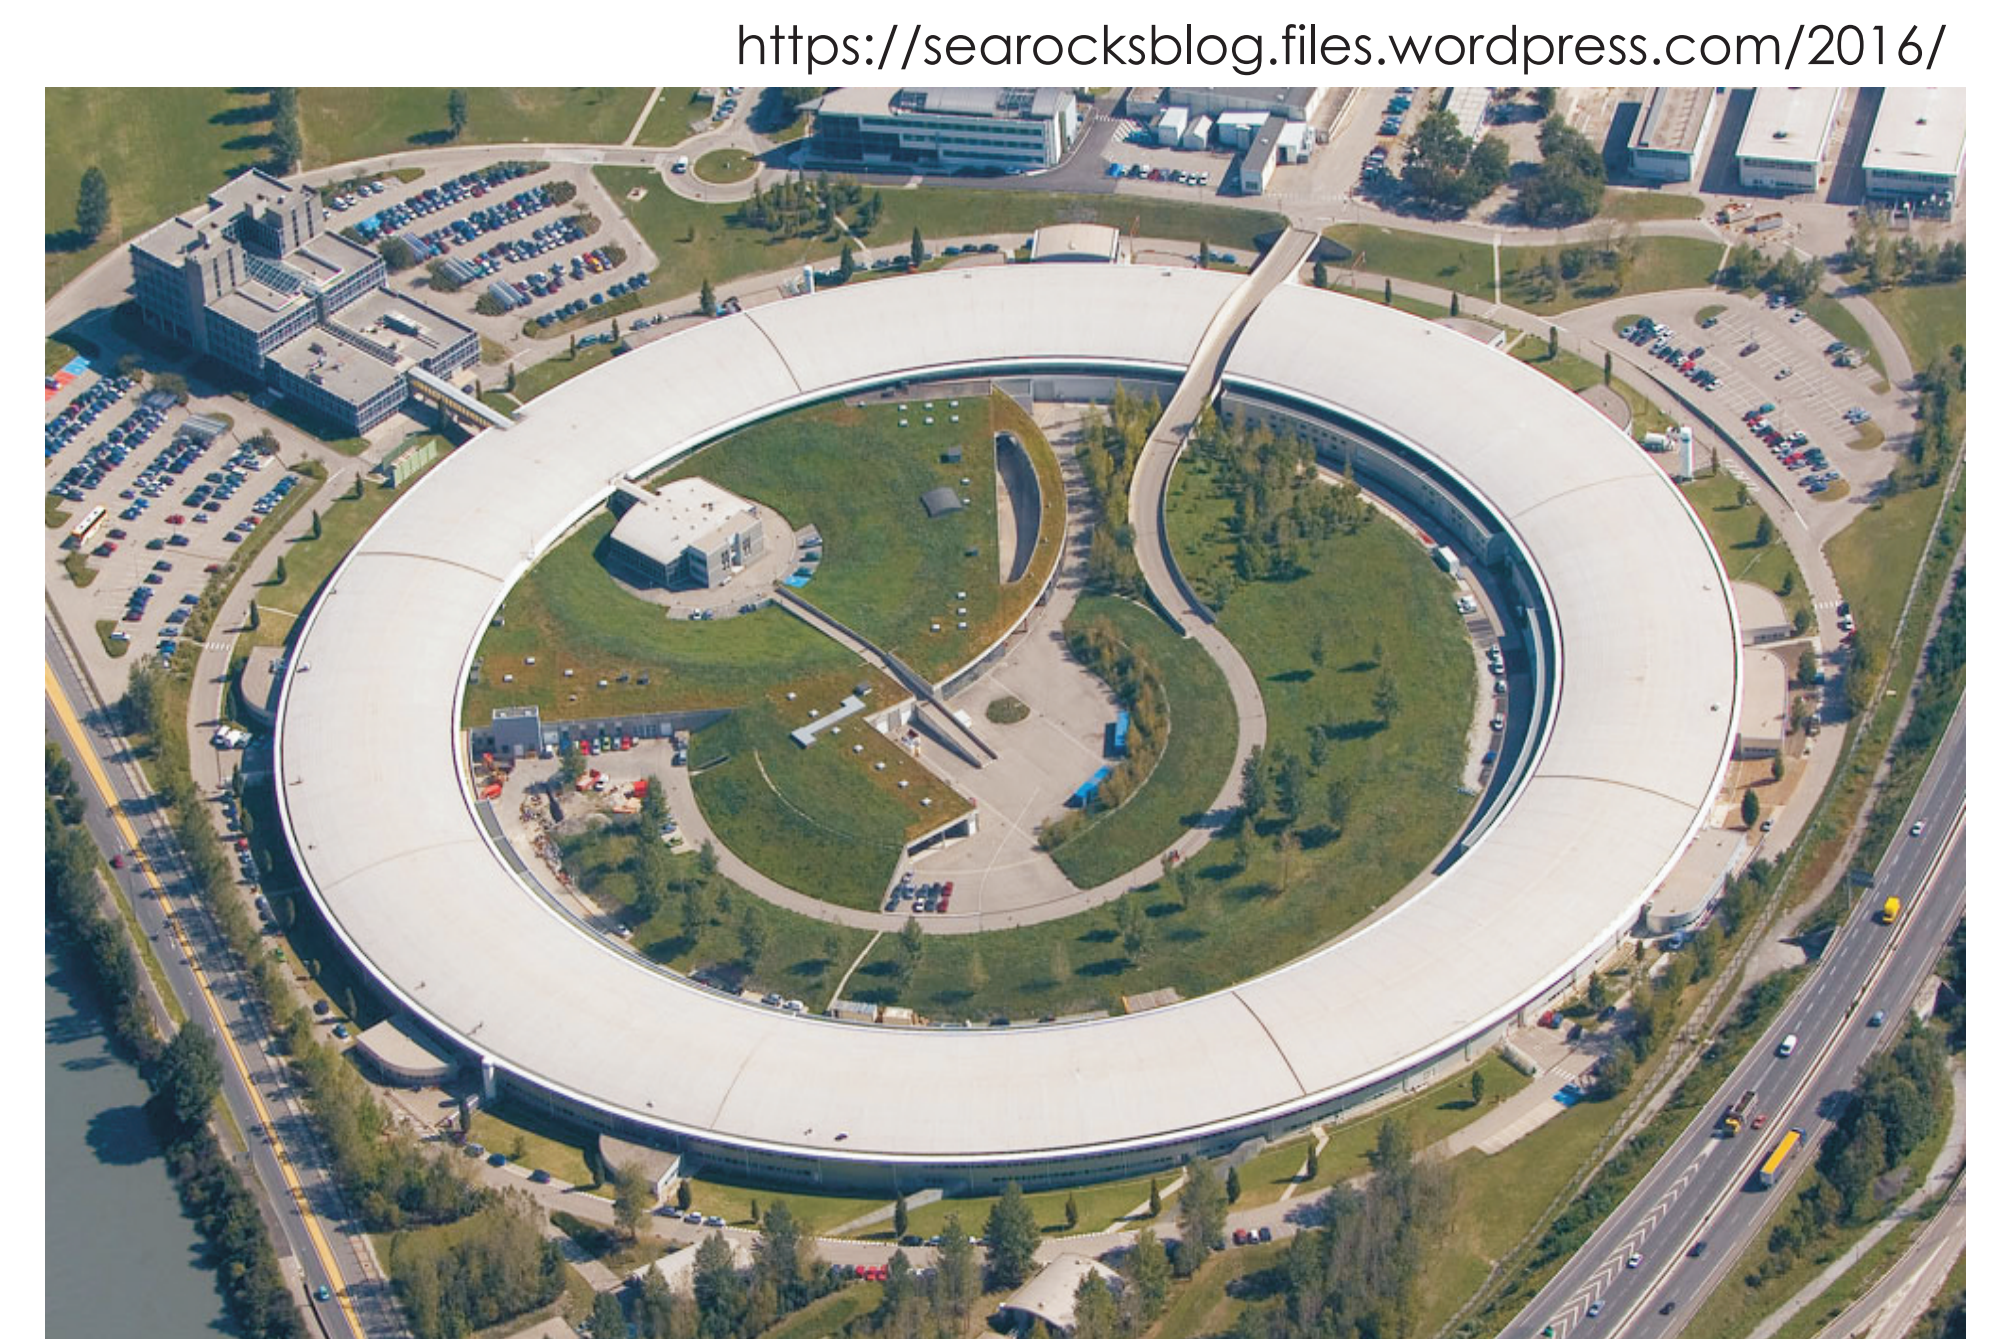
ESRF, electron storage ring, X-ray source at Grenoble in France
