**Scientific Forum Speaker/Panellist Information Form
Vienna, 15-16 September 2015**

HYDROSEDIMENTOLOGY FOR SUSTAINABLE DREDGING IN MARINE & COASTAL WATERS: BETTER INSIGHTS THANKS TO RADIO-ACTIVE TRACERS

**Ir. Bernard Malherbe
Director Project Development
Jan De Nul Group**

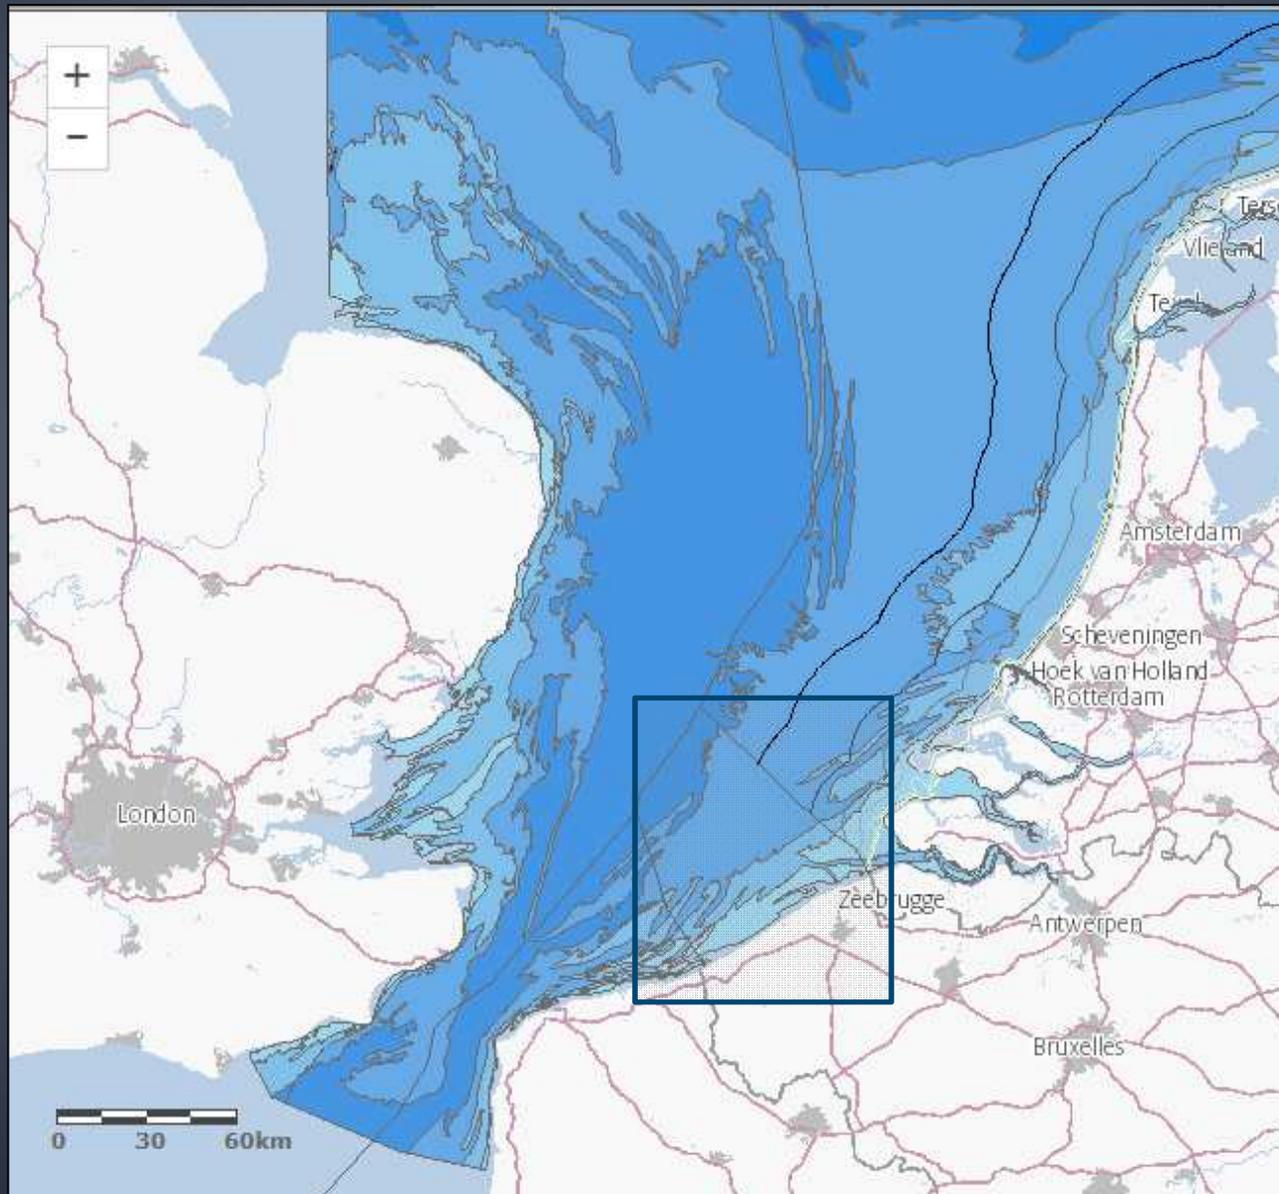
Bathymetry (m
wrt LLWS CD (ref
Noordzee-Atlas)

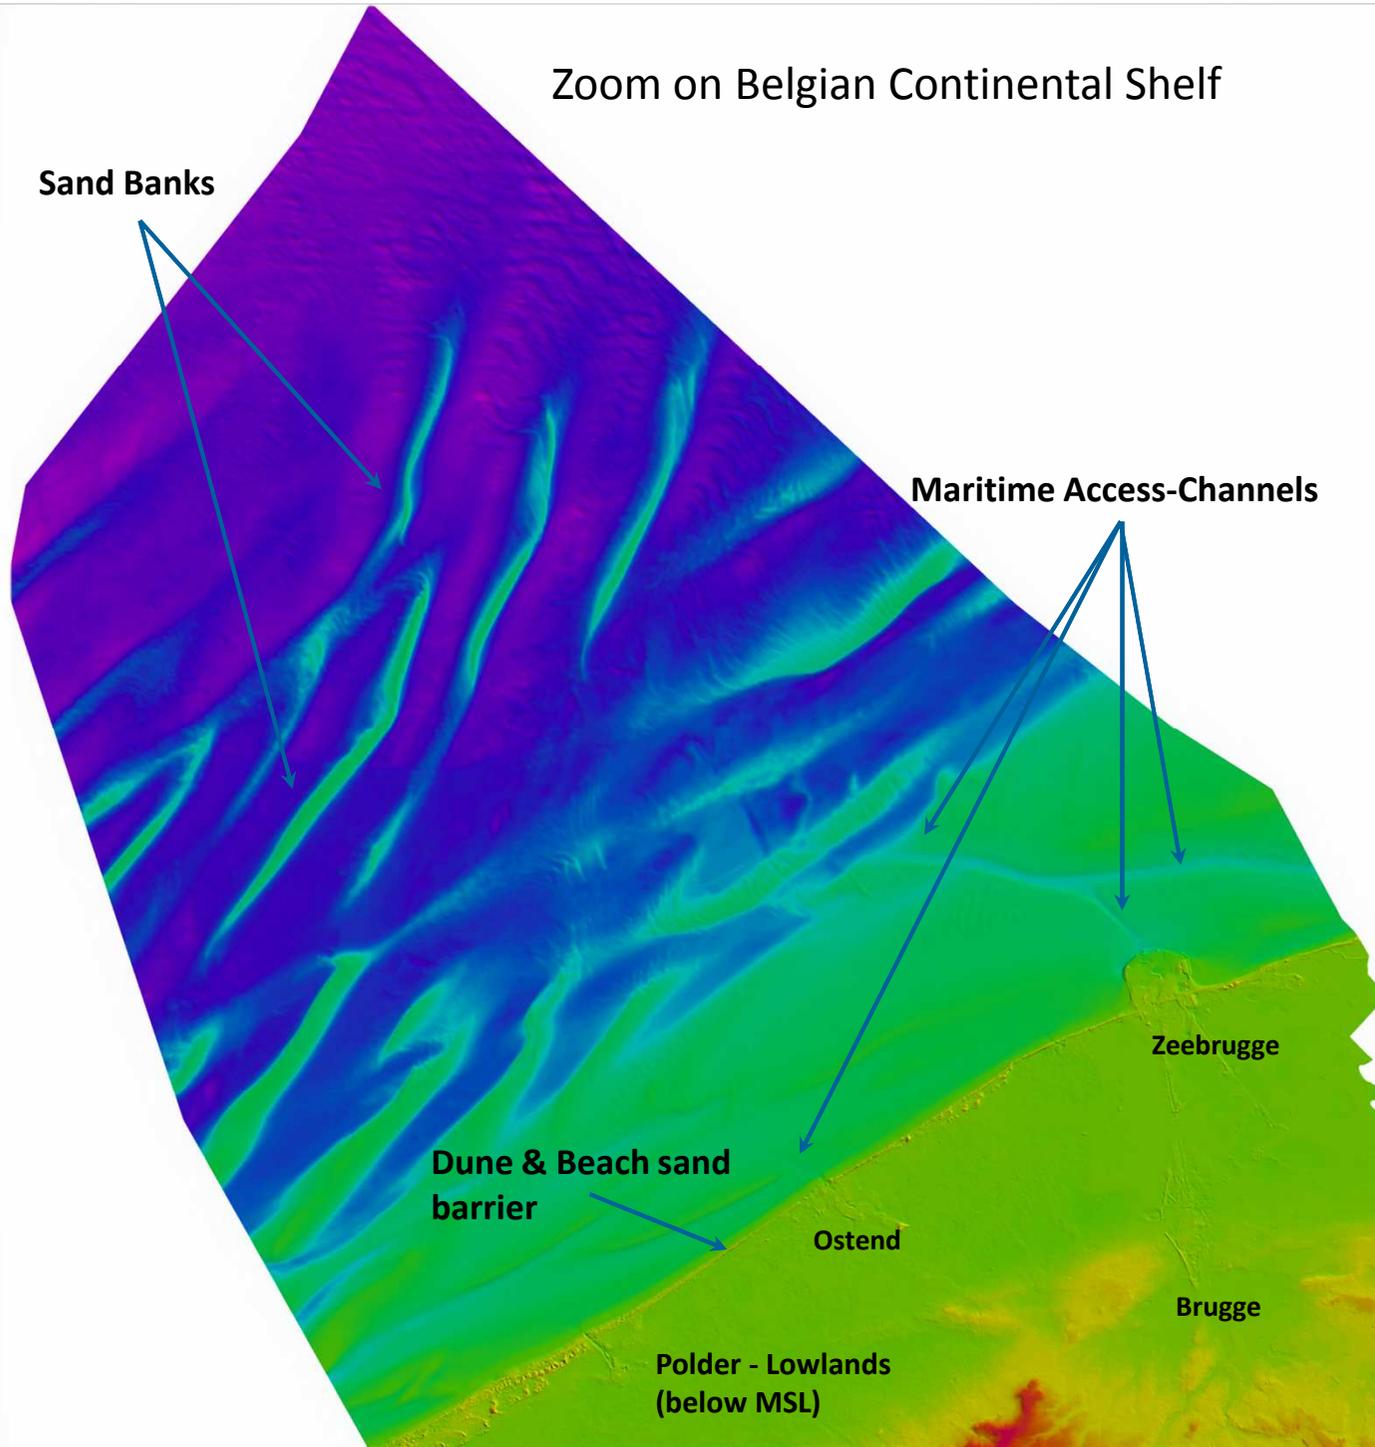
Zoom on Belgian Continental Shelf

Sand Banks

Maritime Access-Channels

Dune & Beach sand barrier

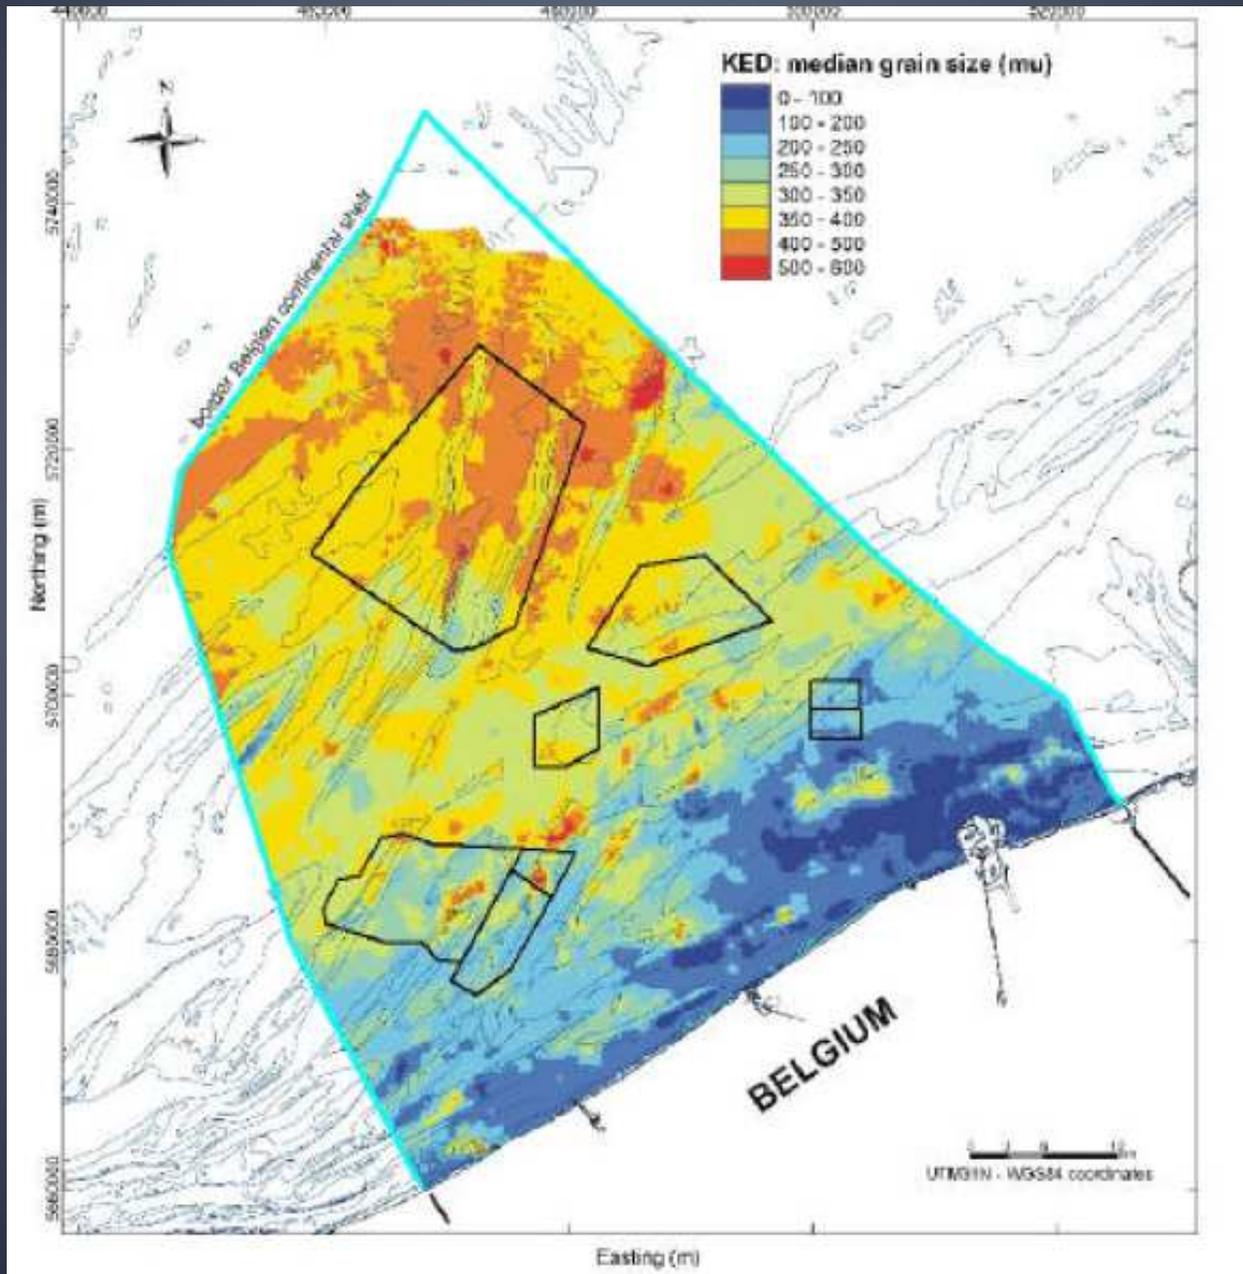
Seabed consist of Quaternary sand and mud sediments (ref Verfaillie et al)

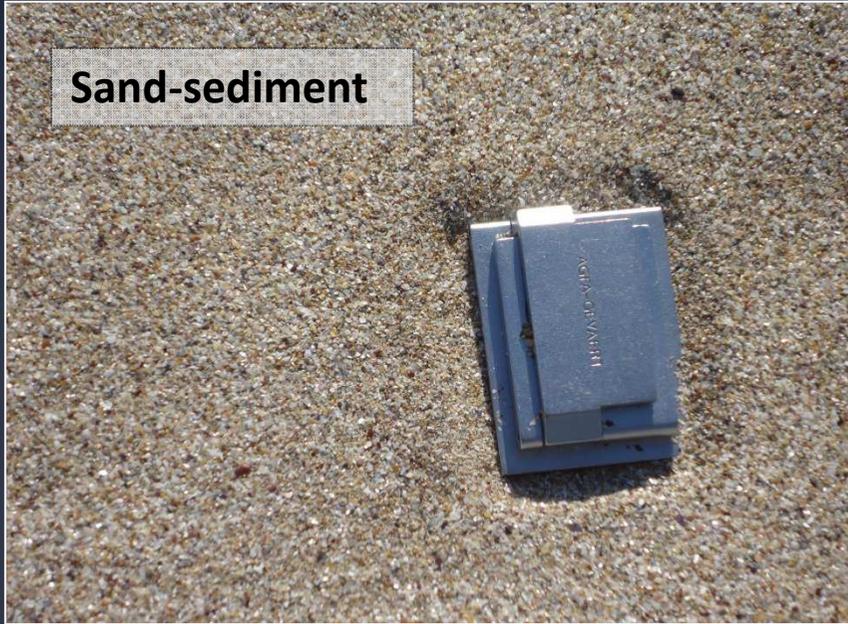
Sand-sediment

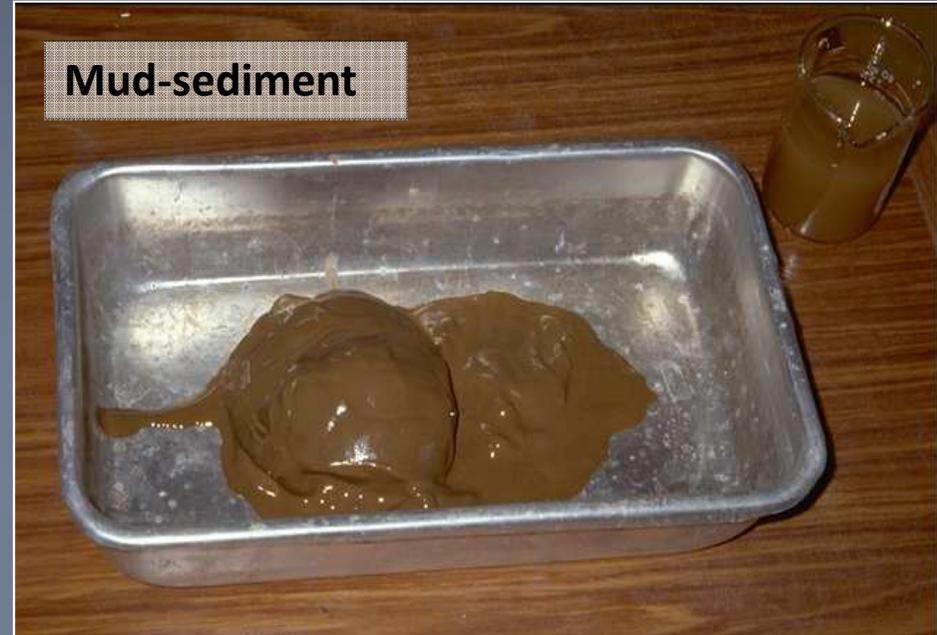
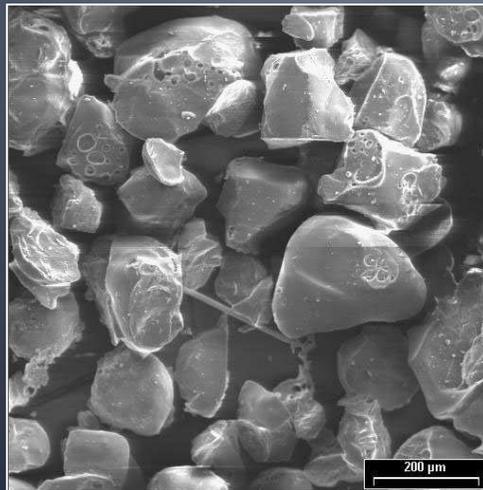
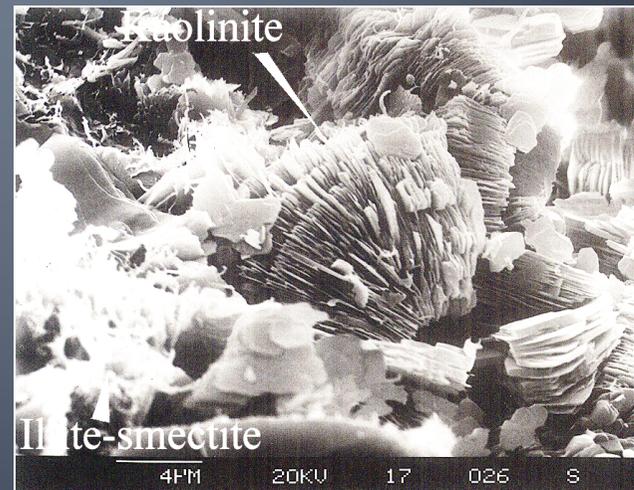
Mud-sediment

Electronic scanning microscope images

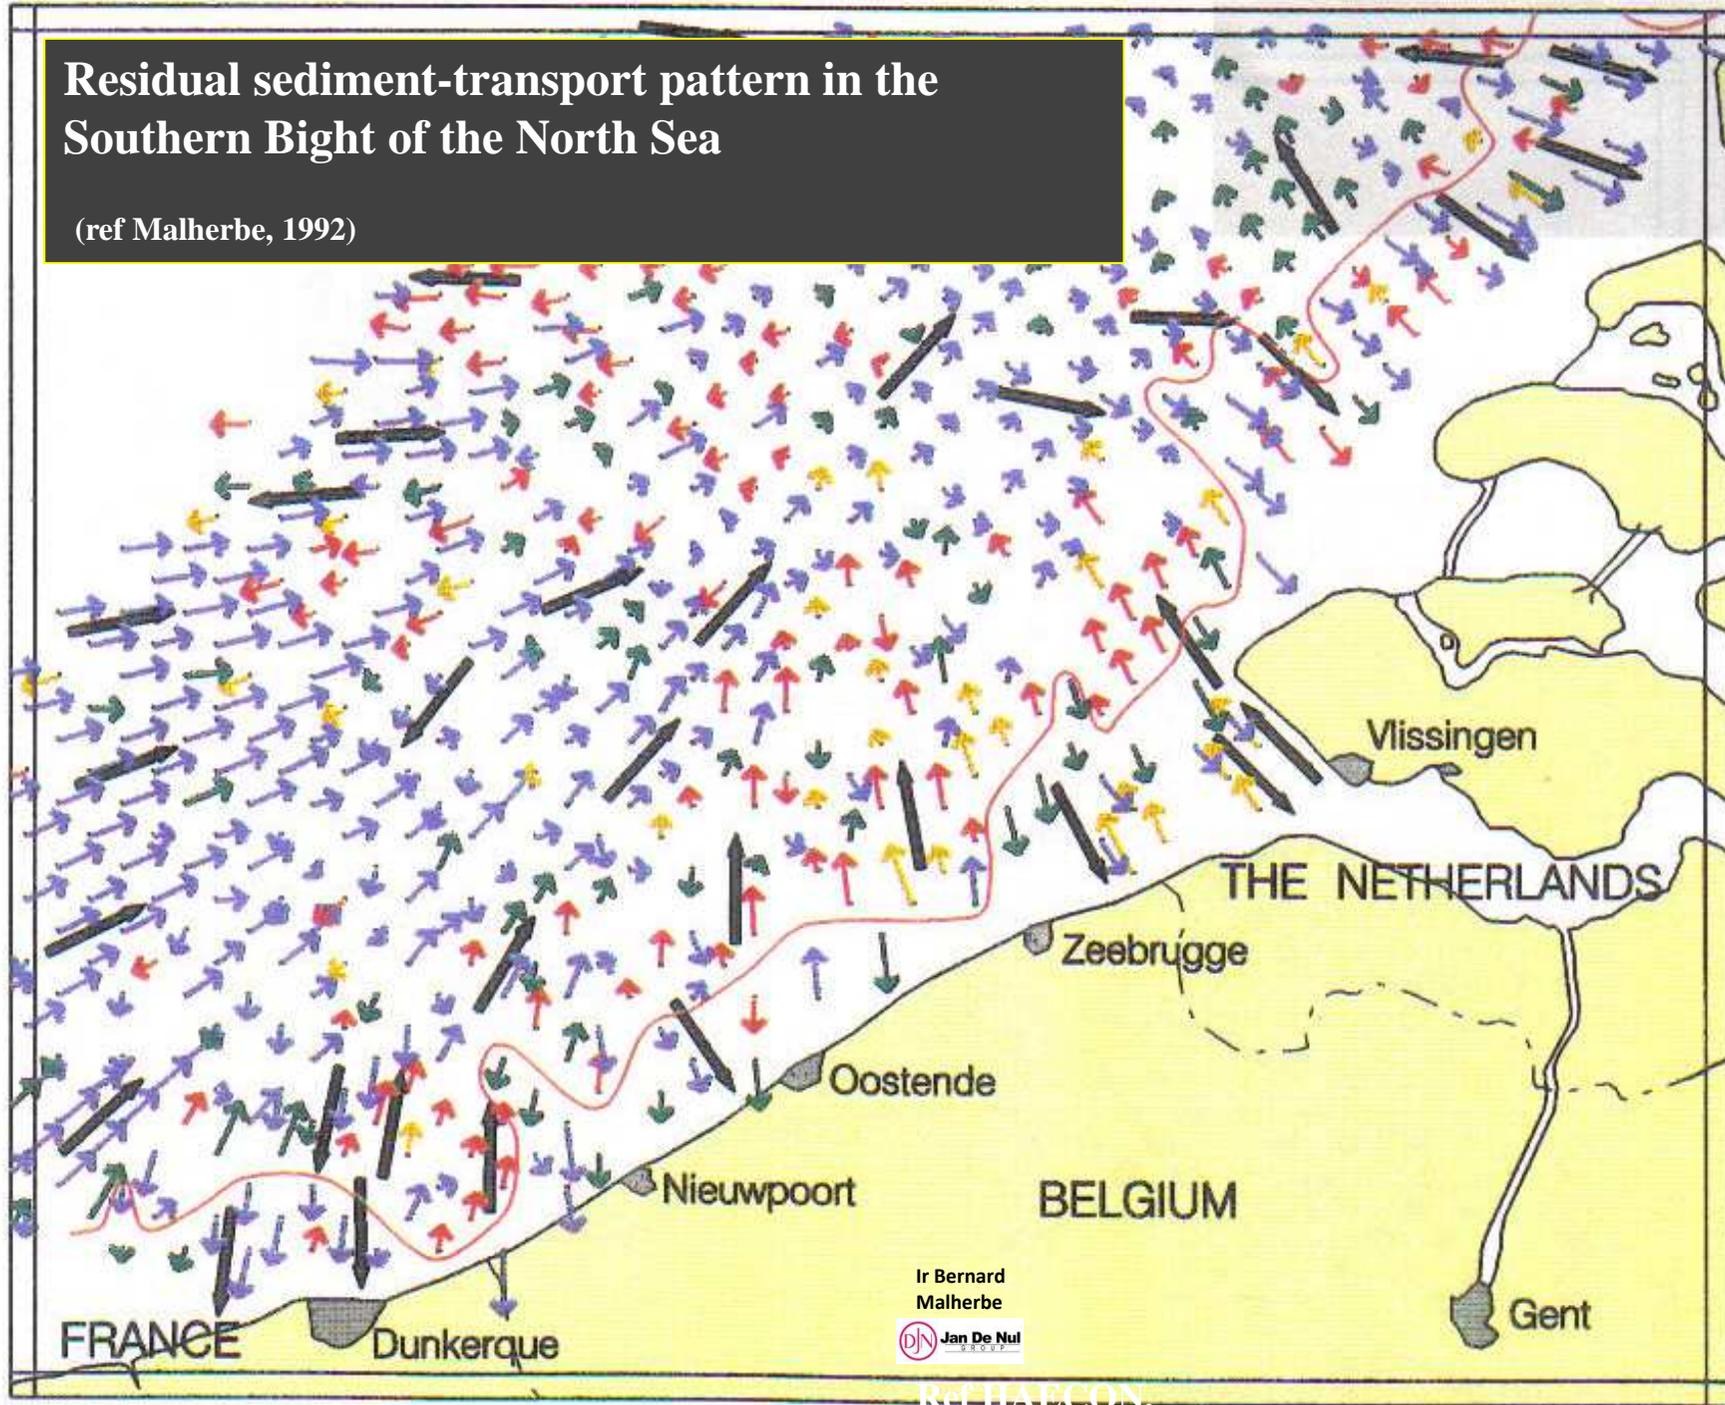
Residual sediment-transport pattern in the Southern Bight of the North Sea

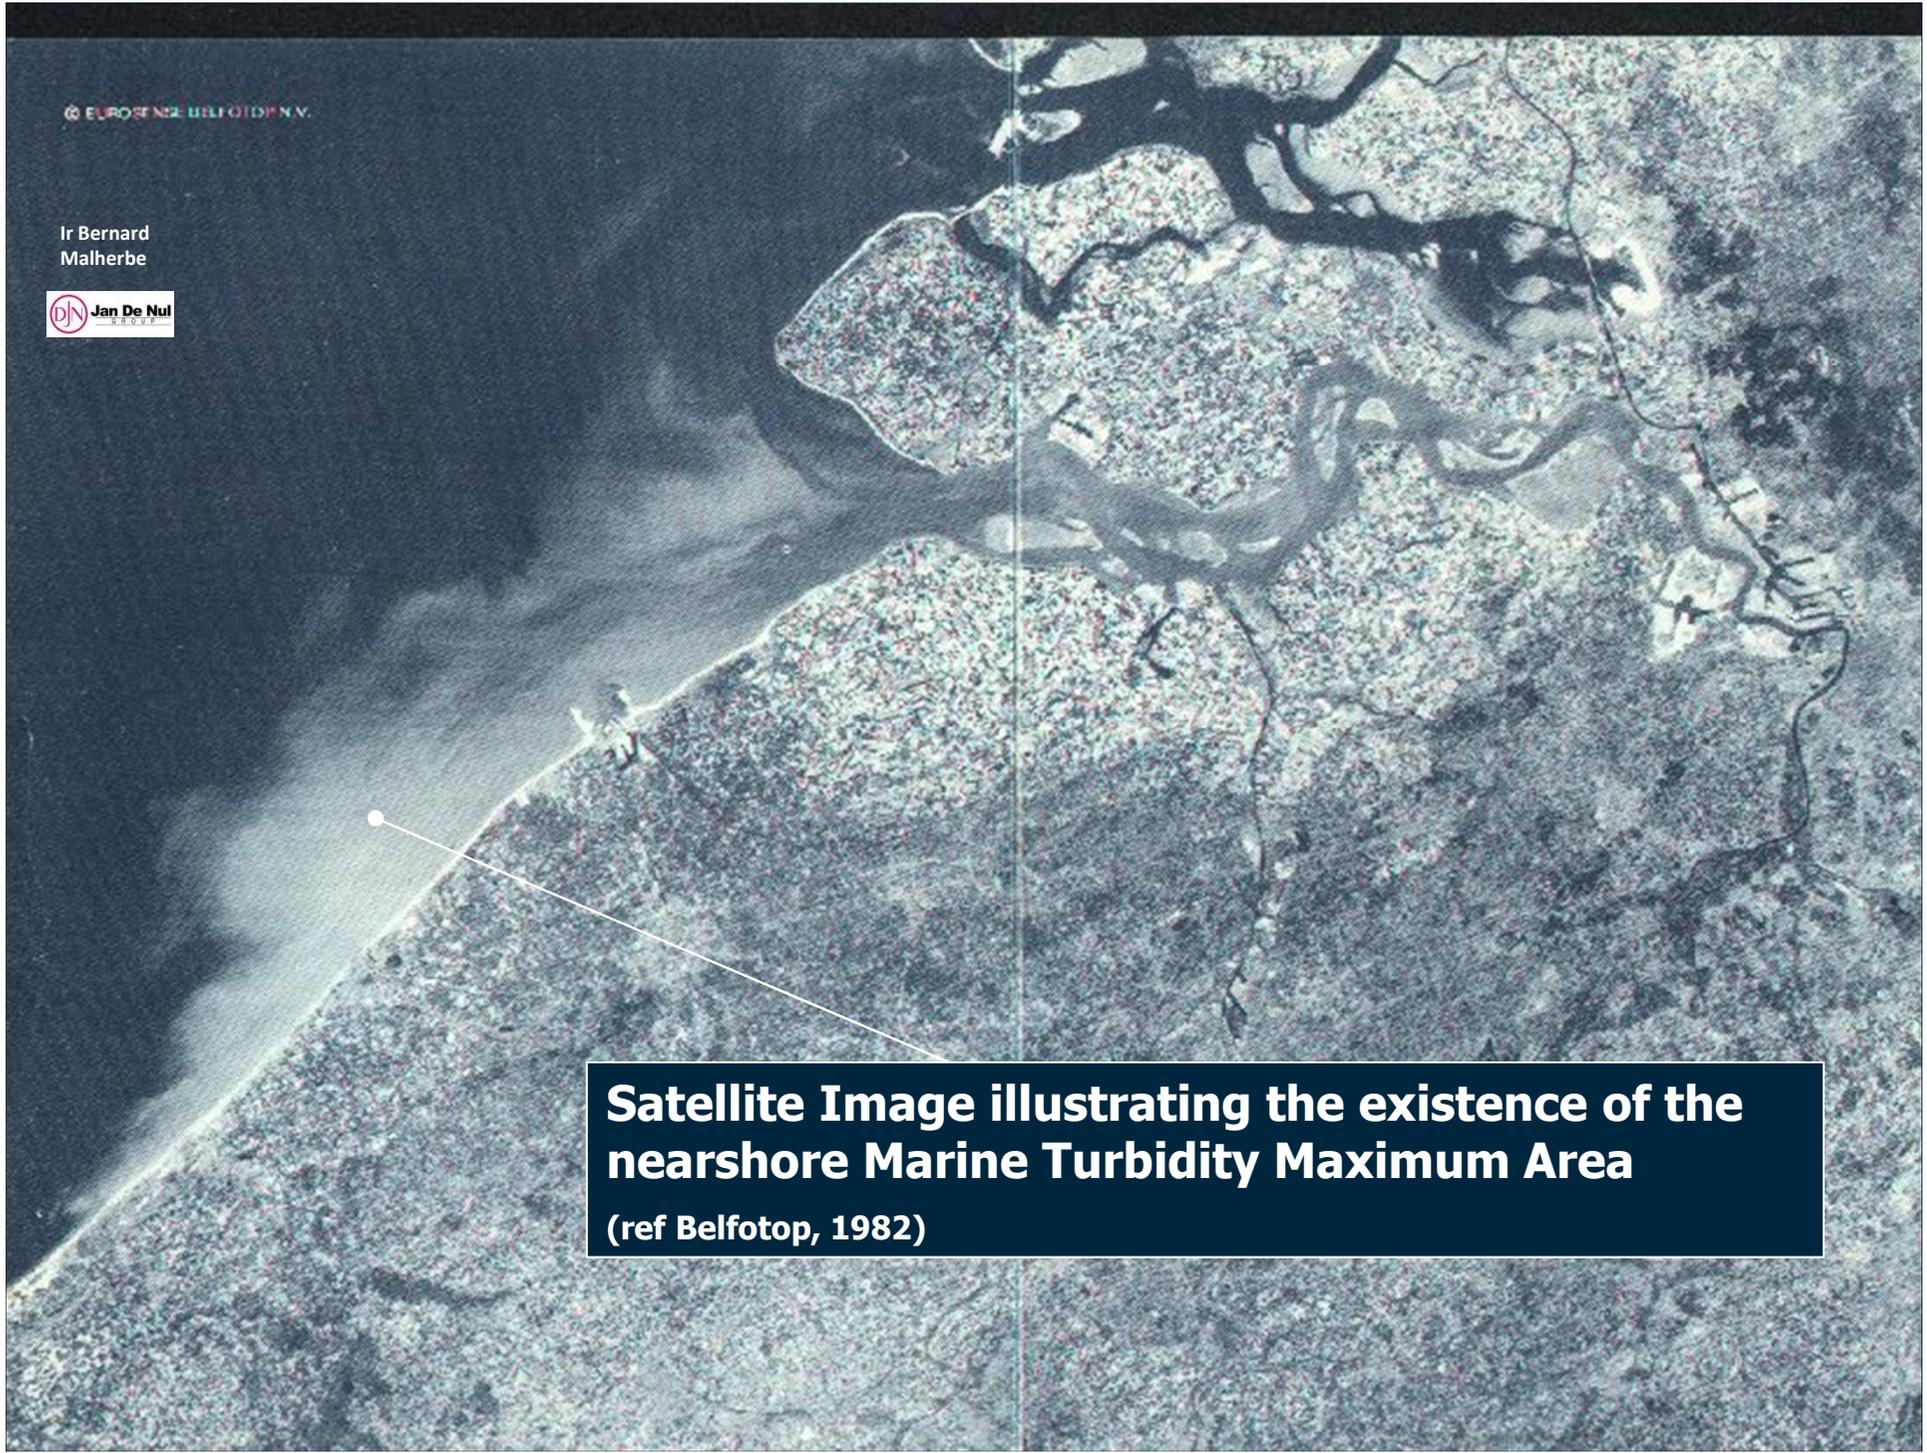
**Satellite Image illustrating the existence of the
nearshore Marine Turbidity Maximum Area
(ref Belfotop, 1982)**

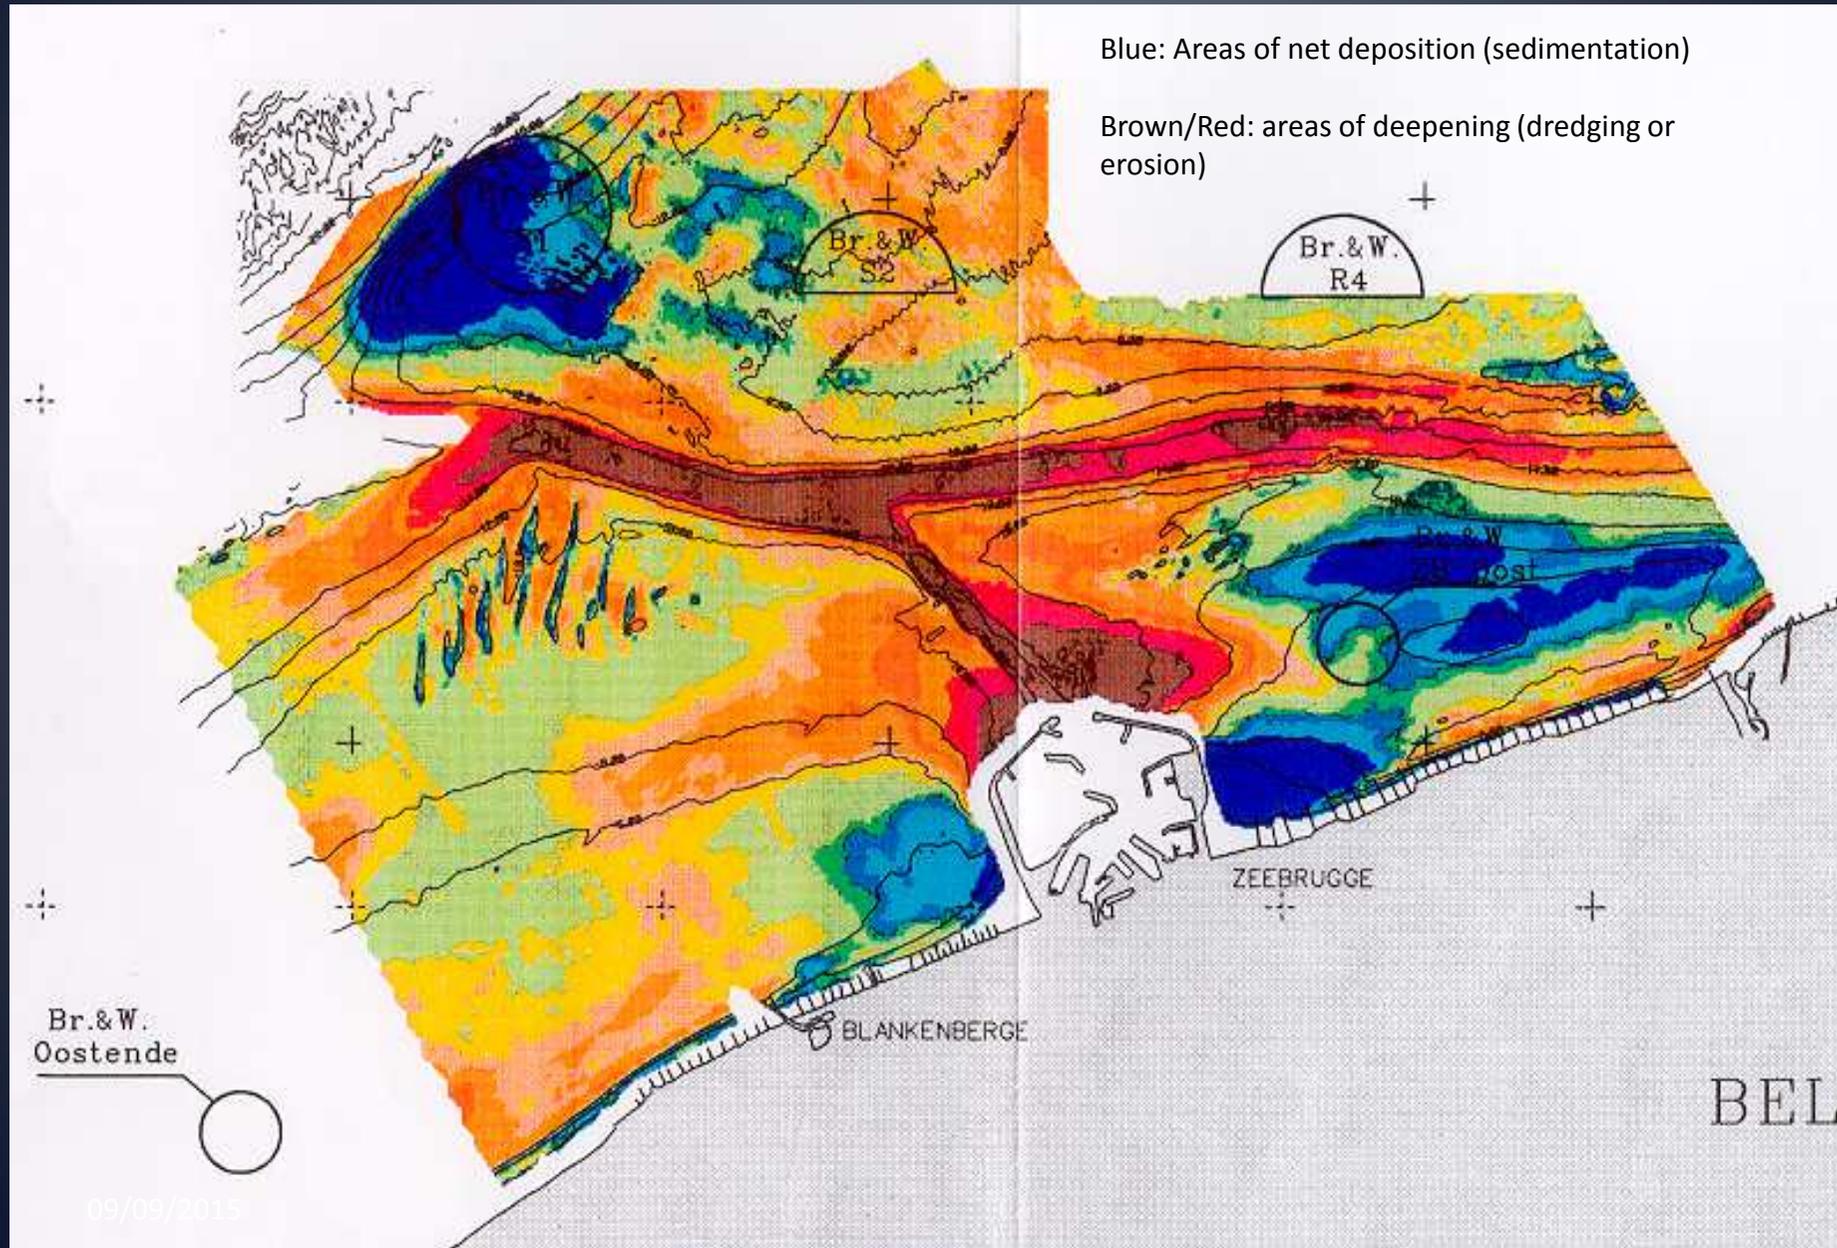
Digital Terrain Model and Differential Mapping (1976-1994) of the Seabed illustrates the effects of port development, channel deepening & coastal protection

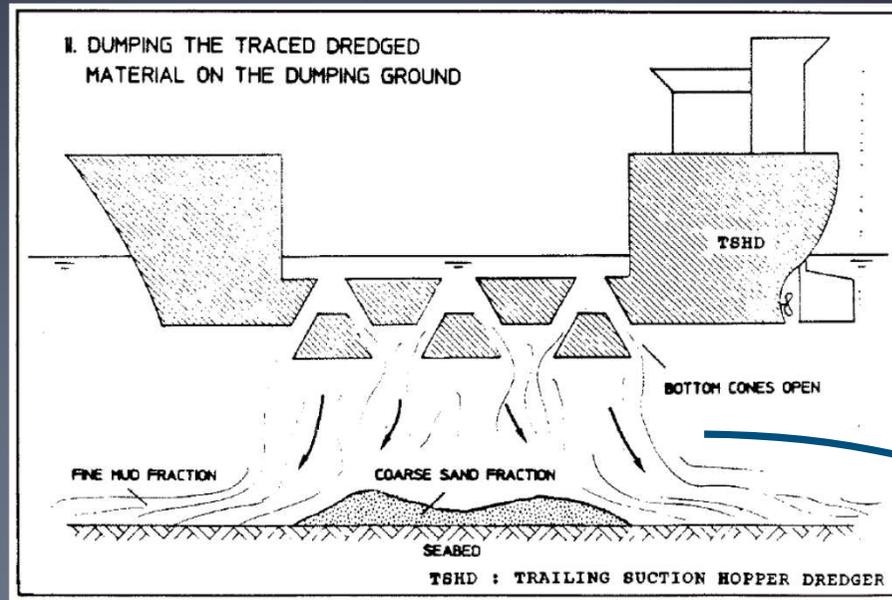
Short-living Au198 radio-active tracers (CEA, Saclay technology) co-precipitated in the alumino-silicate lattice of clay-minerals & detected in-situ with NaI scintillation detectors

Test-results of short-living radio-active tracer experiments

Vertical density flow: 0,5 to 1,5 m/sec

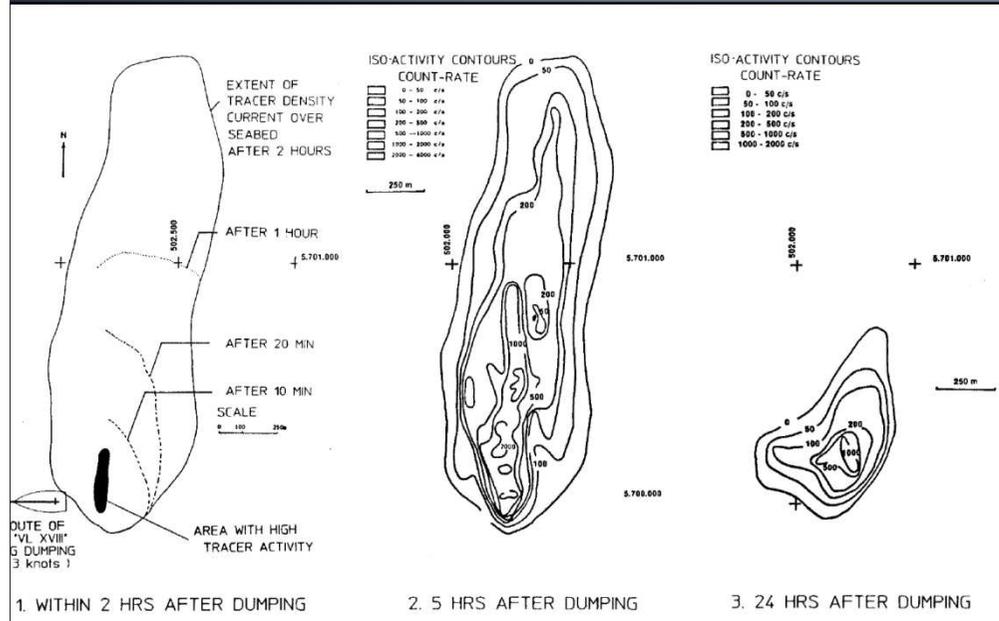
Dumping test of sand & mud

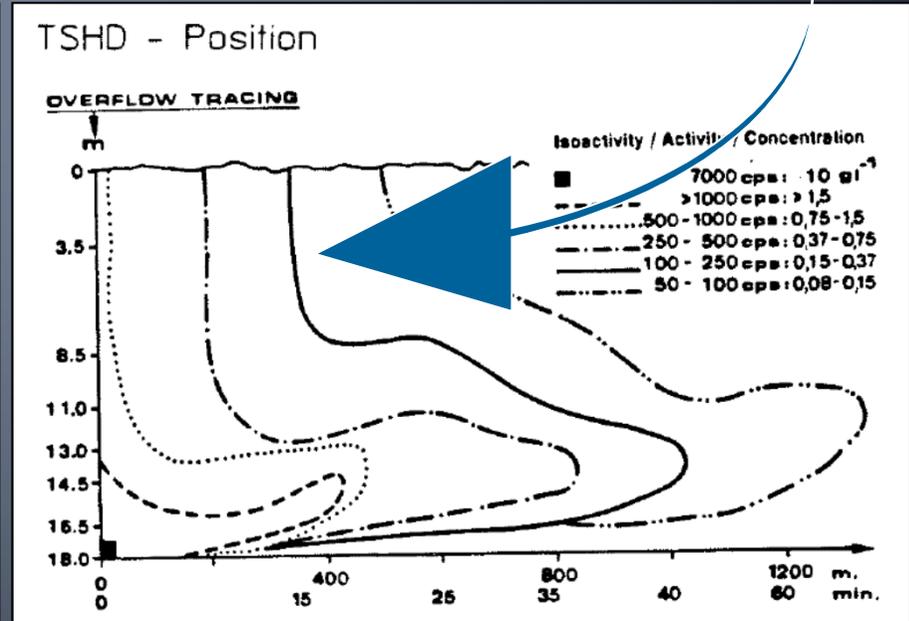
Overflow-test of mud

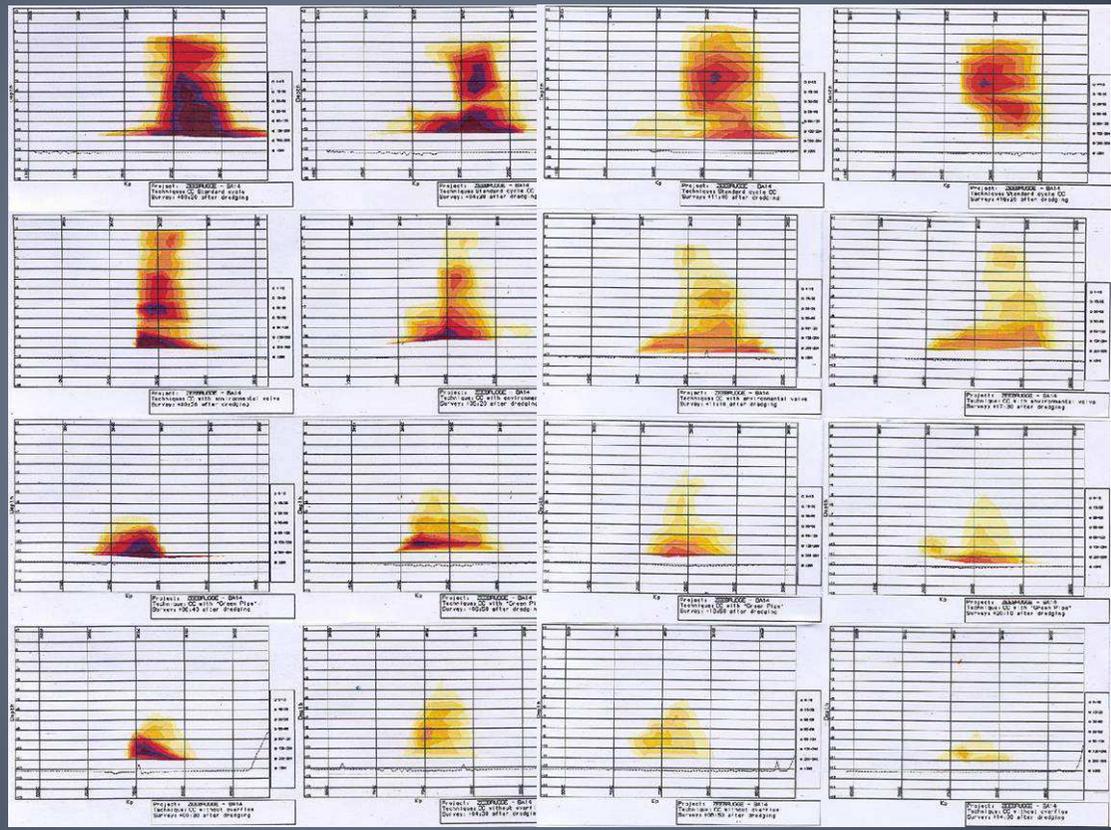
Comparison dredging & environmental-mitigation techniques

Standard overflow

Environmental valve

'Environmental pipe'

No overflow

Time after dredging : 00:30 05:00 10:00 15:00 min

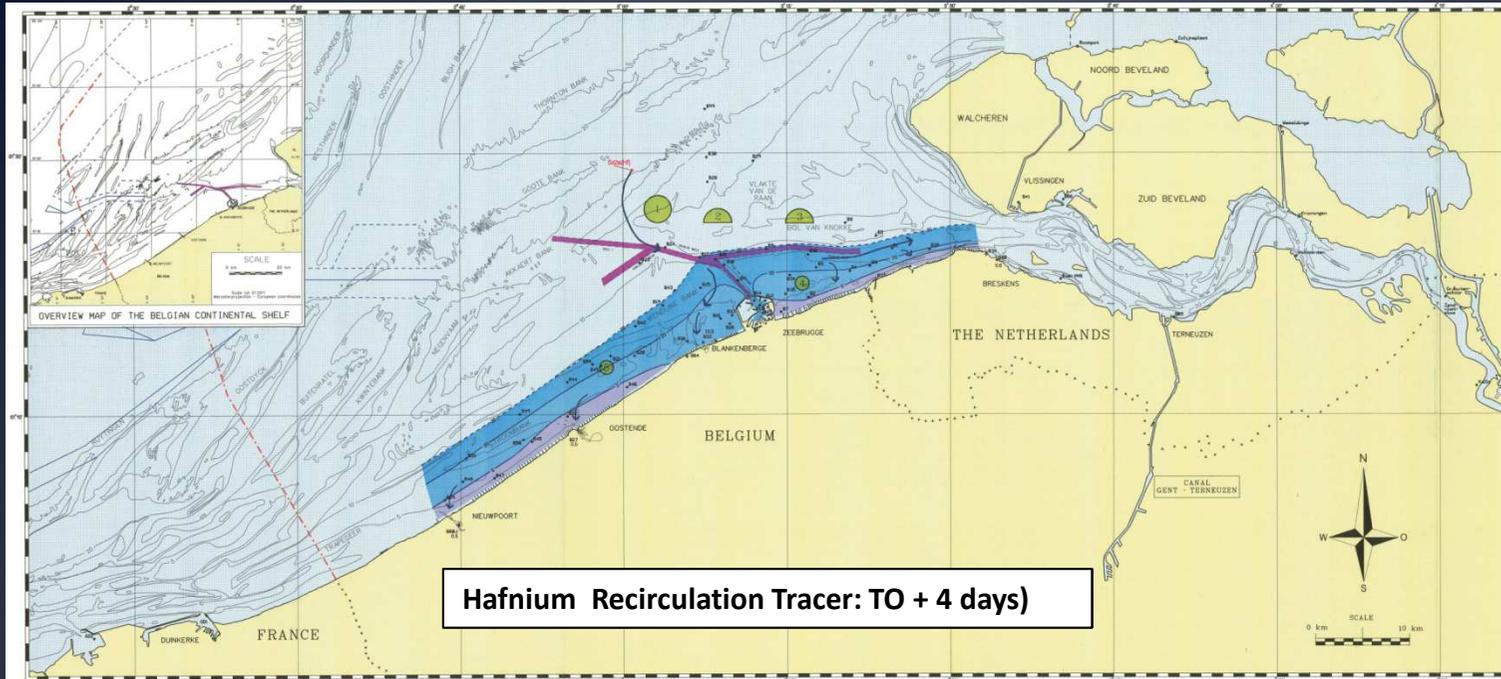
- **Hafnium 175/Hafnium 181 (Th=70d/45d); Act = 1.45×10^{11} Bq**
- **Terbium 160 (Th = 73d) ; Act = 1.50×10^{11} Bq**
- **Physico-chemical co-precipitation of Hf or Tb-solution within the alumino-silicate lattice of clay-particles in the fine-grained sediments and detected via samples in low-background Ge-Li detectors (LNMRI, France)**

THE BELGIAN CONTINENTAL SHELF WITH DUMPING SITES OF DREDGED MATERIAL

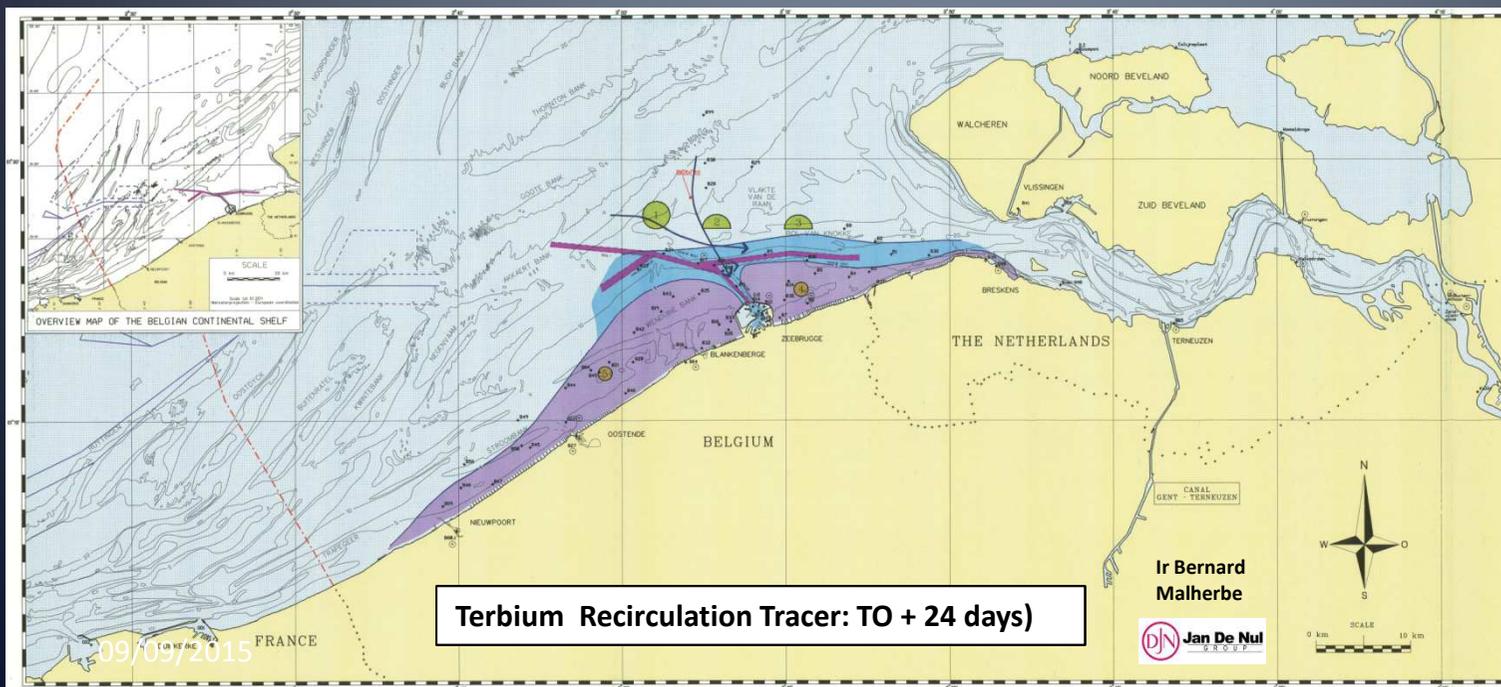
THE BELGIAN CONTINENTAL SHELF WITH DUMPING SITES OF DREDGED MATERIAL

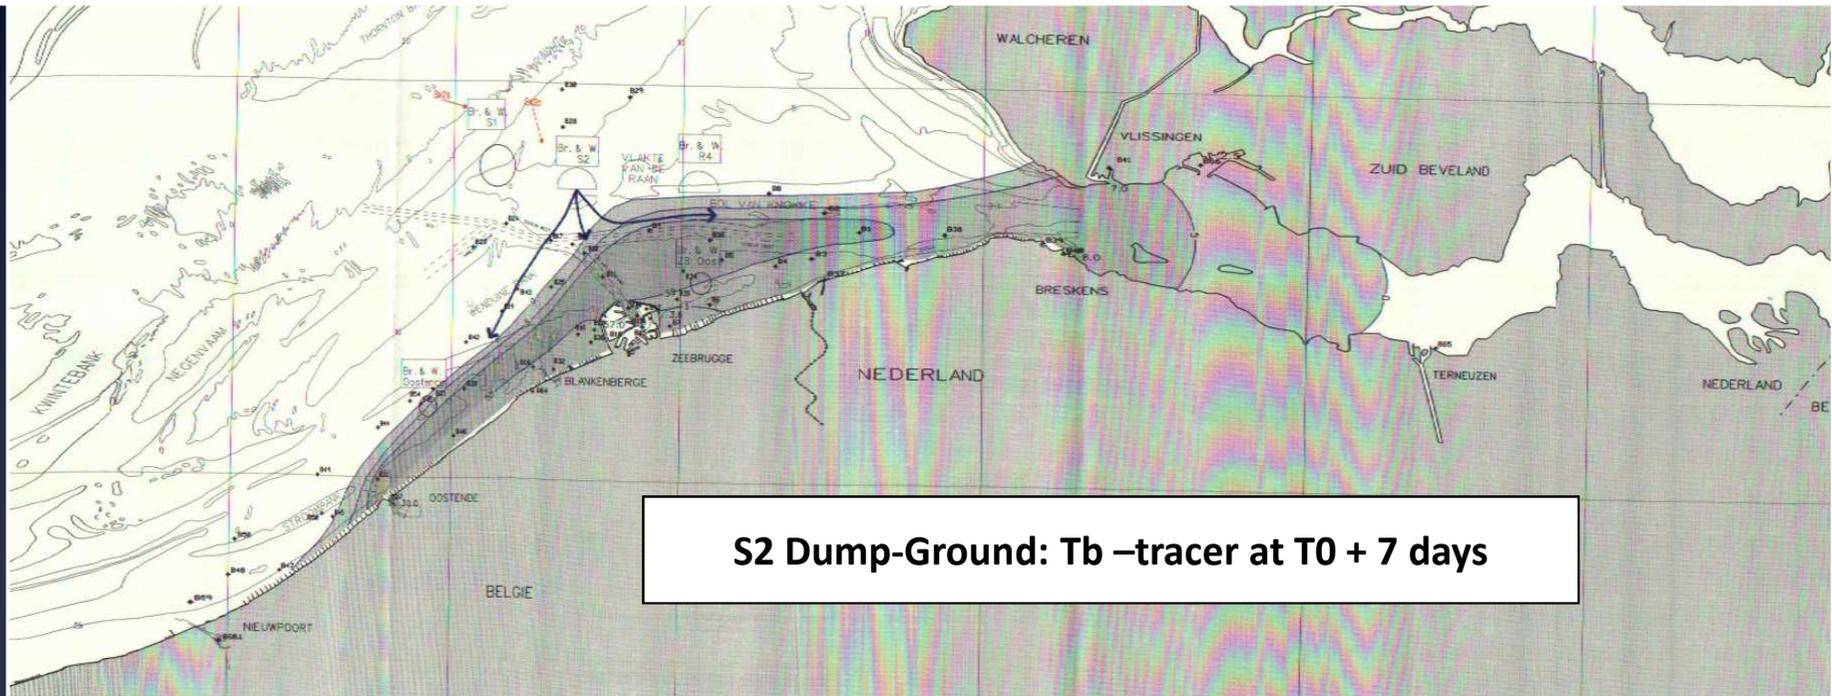
S2 Dump-Ground: Tb-tracer at T0 + 7 days

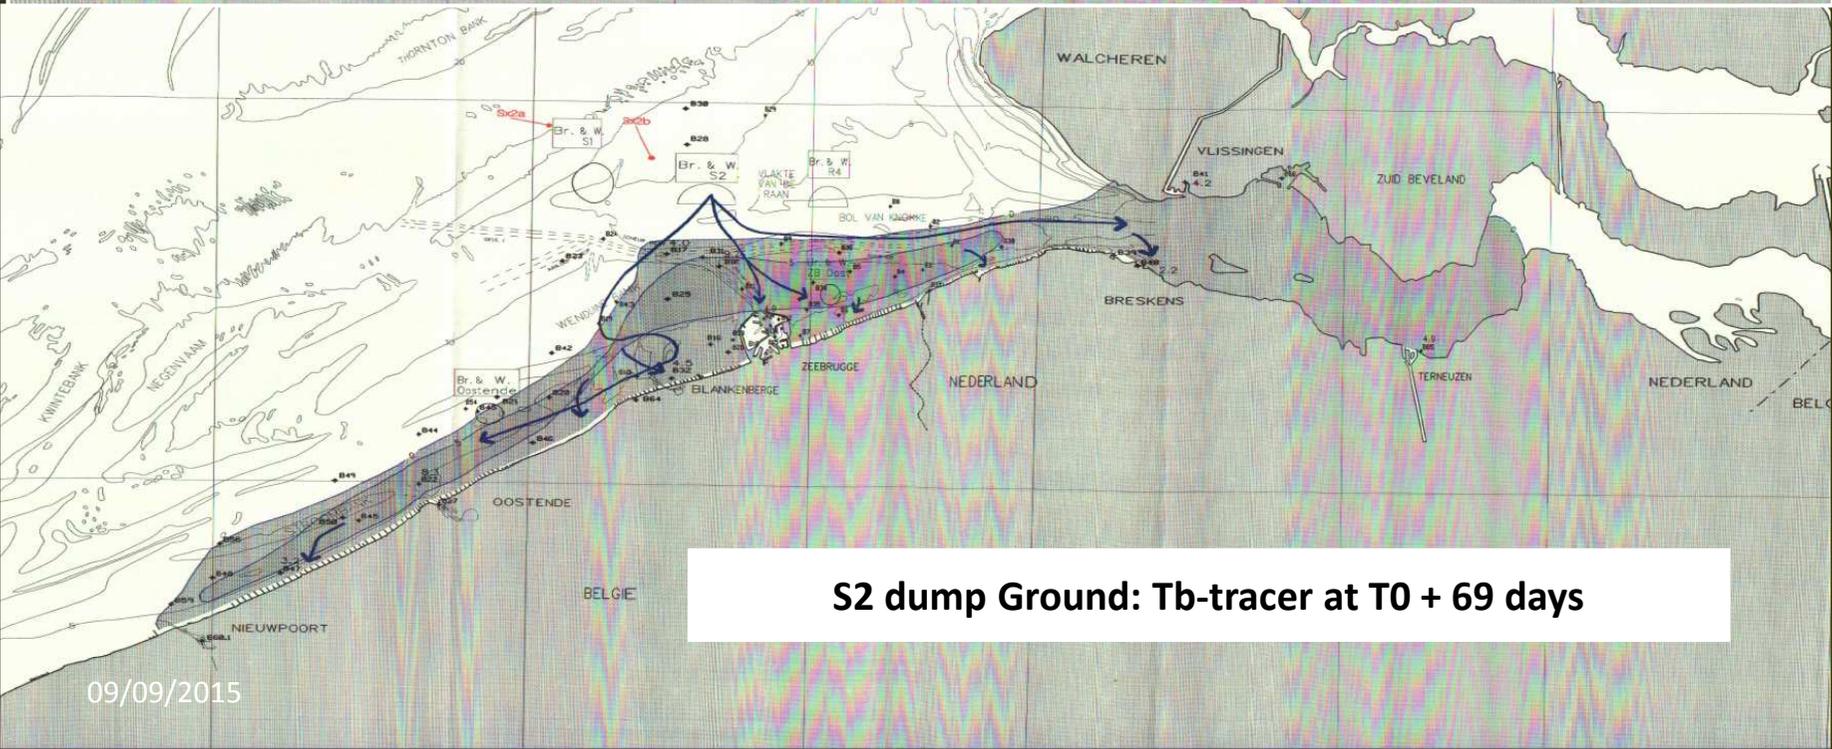
S2 dump Ground: Tb-tracer at T0 + 69 days
