**Scientific Forum Speaker/Panellist Information Form
Vienna, 15-16 September 2015**

HYDROSEDIMENTOLOGY FOR SUSTAINABLE DREDGING IN MARINE & COASTAL WATERS: BETTER INSIGHTS THANKS TO RADIO-ACTIVE TRACERS

**Ir. Bernard Malherbe
Director Project Development
Jan De Nul Group**

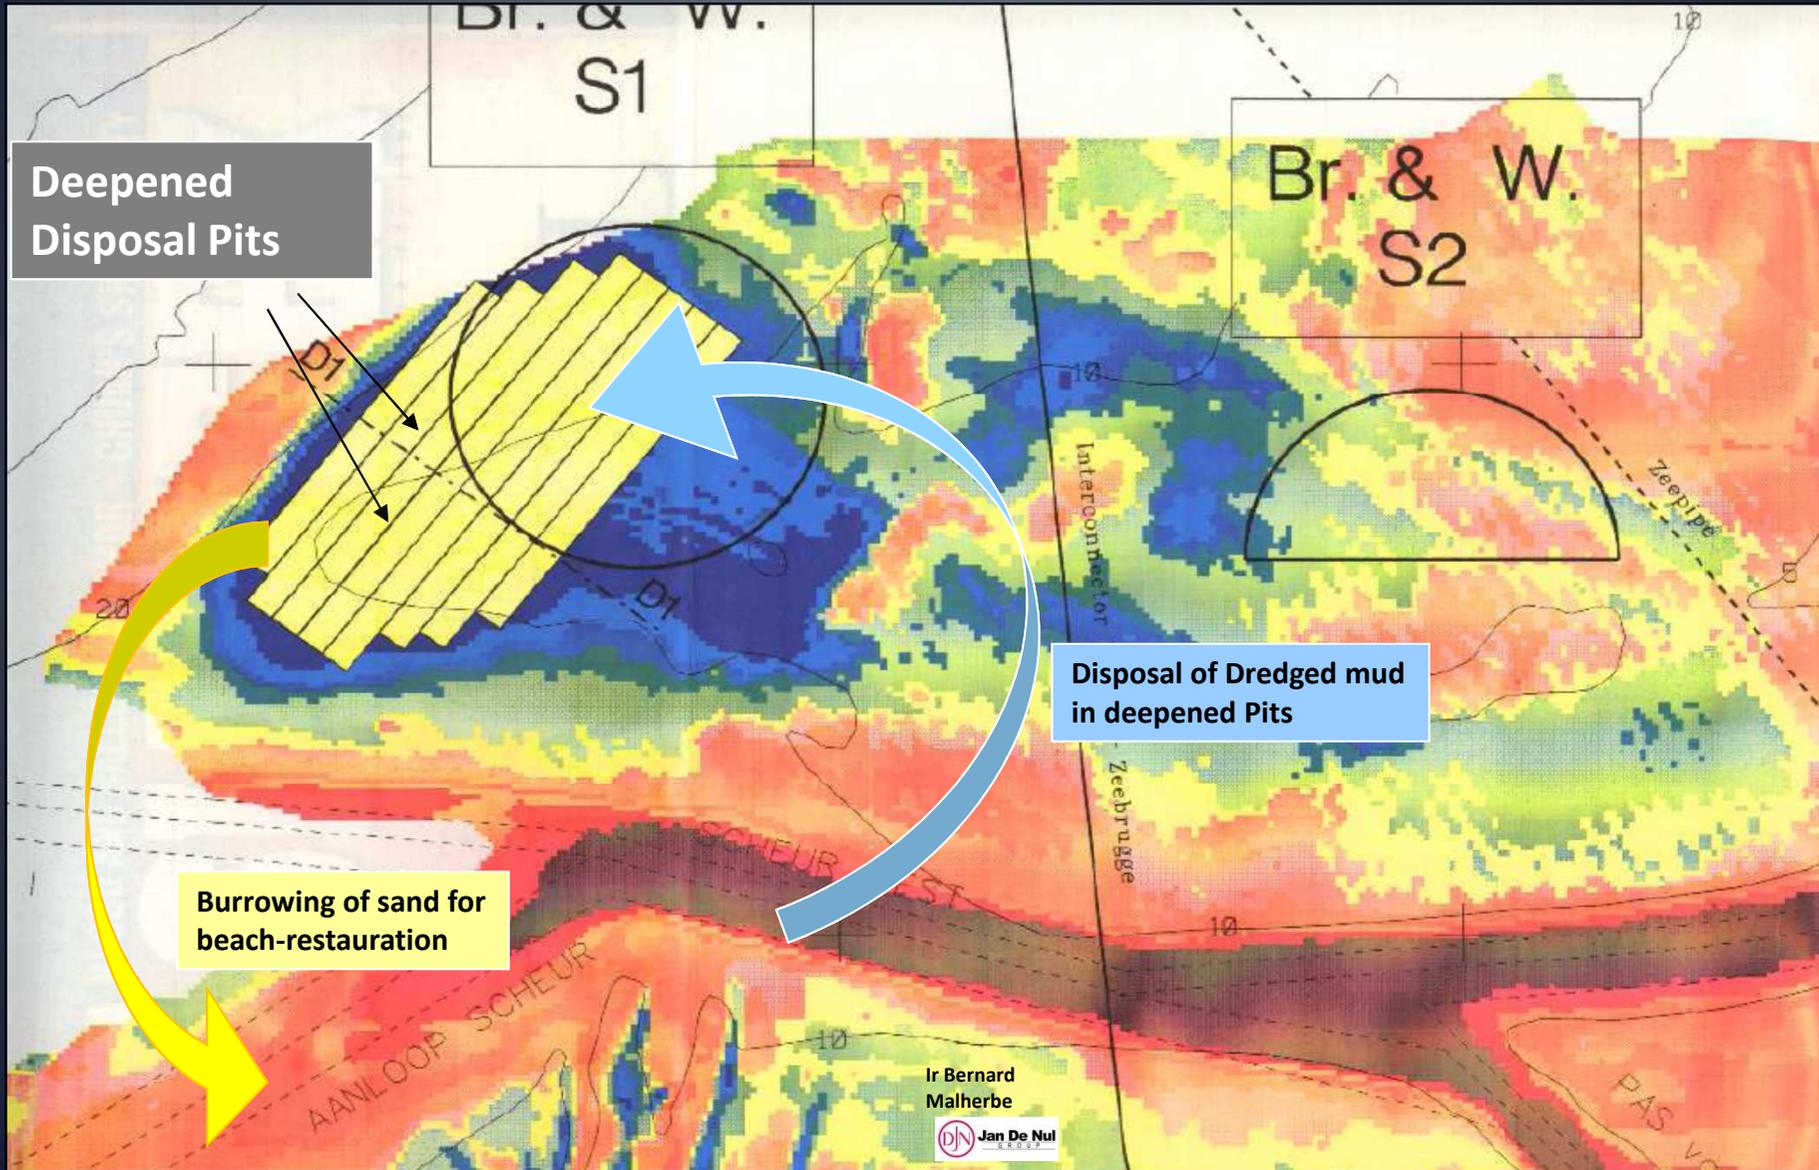
Sustainable Management Plan of Disposal Ground

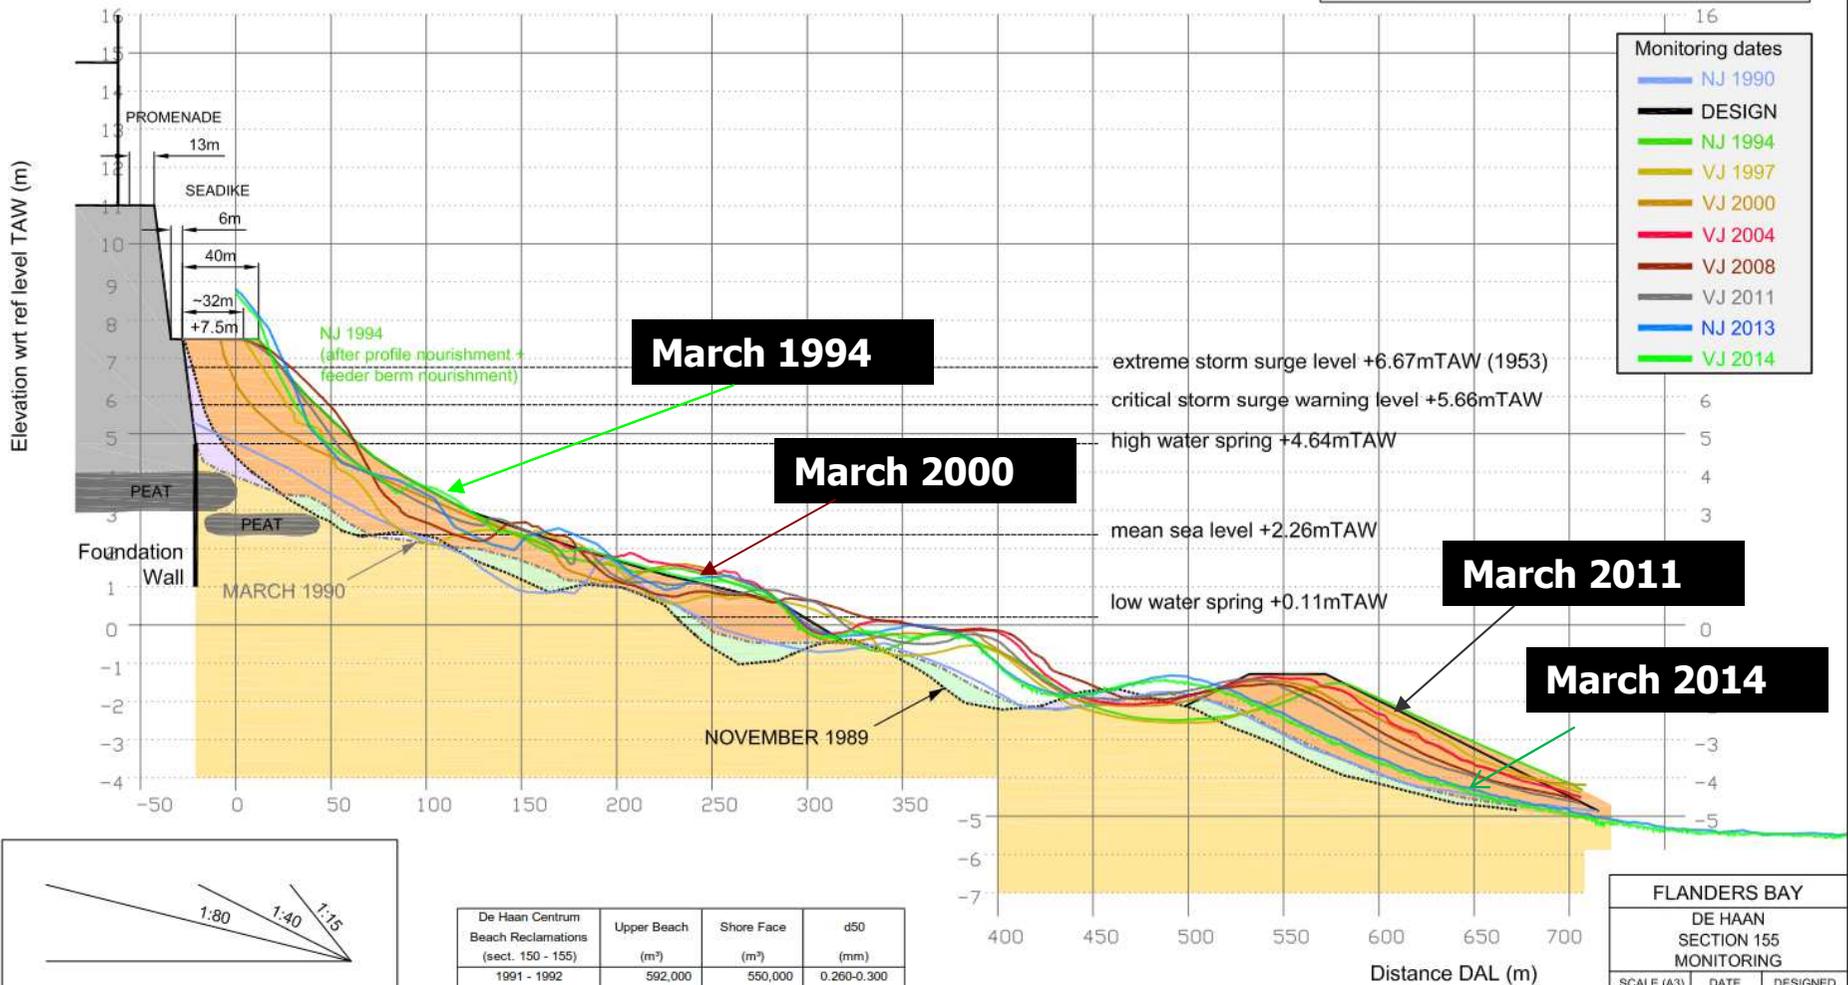
DE HAAN CENTRUM - SECTION 155

Monitoring a geo-engineered beach-nourishment over 20 years

More than 70 % of the once reclaimed sand "stays" in the primary beach barrier system and is redistributed in the ridge& runnel pattern

MONITORING OF SECTION 155

- EROSION AFTER FEB'90 STORM
- SEDIMENTATION AFTER FEB'90 STORM
- ORIGINAL BEACH

De Haan Centrum Beach Reclamations (sect. 150 - 155)	Upper Beach (m ²)	Shore Face (m ²)	d50 (mm)
1991 - 1992	592,000	550,000	0.260-0.300
2000	260,493		0.270
