Comprehensive Risk Review of all the possible risks which might have an impact outside the site boundary of the Fukushima Daiichi Nuclear Power Station

~ Result of Comprehensive Risk Review ~

April 28, 2015

Tokyo Electric Power Company

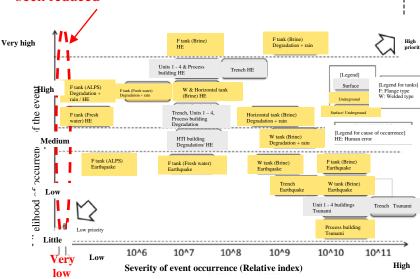
(Risk map further broadening the target*)

Target items which have potential impact on outside the site boundary including those having very small impact are evaluated in the situation where risks as a whole have been reduced
