## Main works and steps for decommissioning

## Progress status

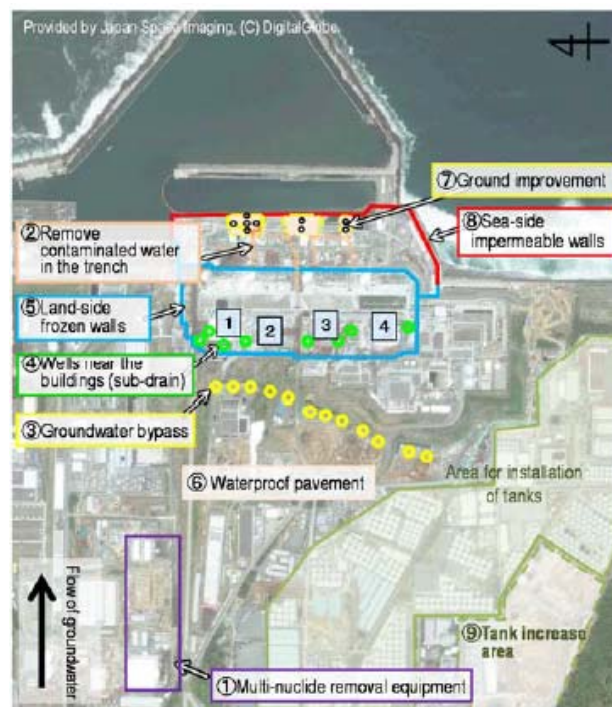
Countermeasures for contaminated water (Note 2) are implemented with the following three principles:

### 1. Eliminate contamination sources

- (1) Multi-nuclide removal equipment
  - (2) Remove contaminated water in the trench (Note 3)
- (Note 3) Underground tunnel containing pipes.

### 2. Isolate water from contamination

- (3) Pump up ground water for bypassing
- (4) Pump up ground water near buildings
- (5) Land-side frozen walls
- (6) Waterproof pavement

### 3. Prevent leakage of contaminated water

- (7) Soil improvement by sodium silicate
- (8) Sea-side impermeable walls
- (9) Increase tanks (welded-joint tanks)

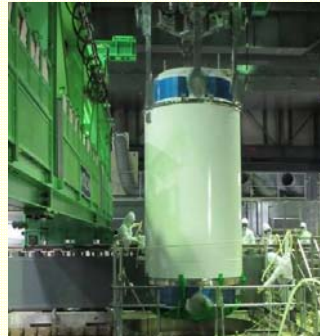
<Work conditions for transfer of the final fuel transportation container>

## Fuel removal from the Unit 4 spent fuel pool completed

Fuel removal from the Unit 4 spent fuel pool (SFP) commenced on November 18, 2013. On November 5, within a year since this work commenced, the transfer of spent fuel assemblies in the pool to the common pool was completed.

The transfer of non-irradiated fuel assemblies to the Unit 6 SFP was also completed on December 22.

This marks the completion of all fuel removal from the Unit 4. Based on this experience, fuel assemblies will be removed from the Unit 1-3 pools.

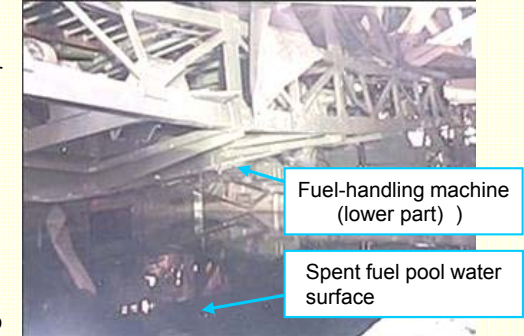
<Status of rubble at the upper part of the Unit 1 spent fuel pool>

## Investigation into the status of rubble and dust on the Unit 1 R/B top floor

Two roof panels of the Unit 1 Reactor Building (R/B) cover were removed, investigations into the status of rubble and the concentration of dust on the R/B top floor (operating floor) were conducted, and the roof panels were put back on December 4. A hole used for spraying of anti-scattering agents that had been expanded in October was also covered at that time.

The result of these investigations confirmed that no scattering of dust or conditions that would cause immediate damage to the fuel assemblies in the SFP were detected. It is scheduled for the roof panels to be removed once again after March, and for careful work to dismantle the roof covers to proceed.

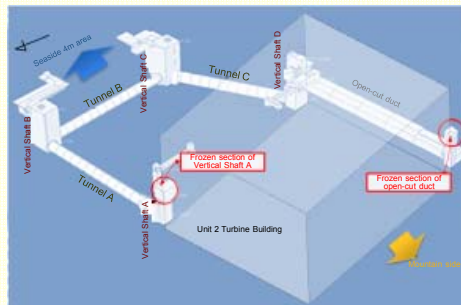
<Image of Unit 2 seawater-pipe trench>

## Filling of Unit 2 seawater-pipe trench tunnel sections completed

Filling of the seawater-pipe trench (Note) which leads from the Turbine Building of Unit 2 on the sea side, with cement-based materials, commenced on November 25, and on December 18 the filling of the tunnel sections was completed.

After water is pumped up from the Vertical Shafts and the filling status of the tunnel sections is confirmed, preparations for filling the Vertical Shaft sections will proceed.

Note: The term 'trench' means an underground tunnel containing pipes.

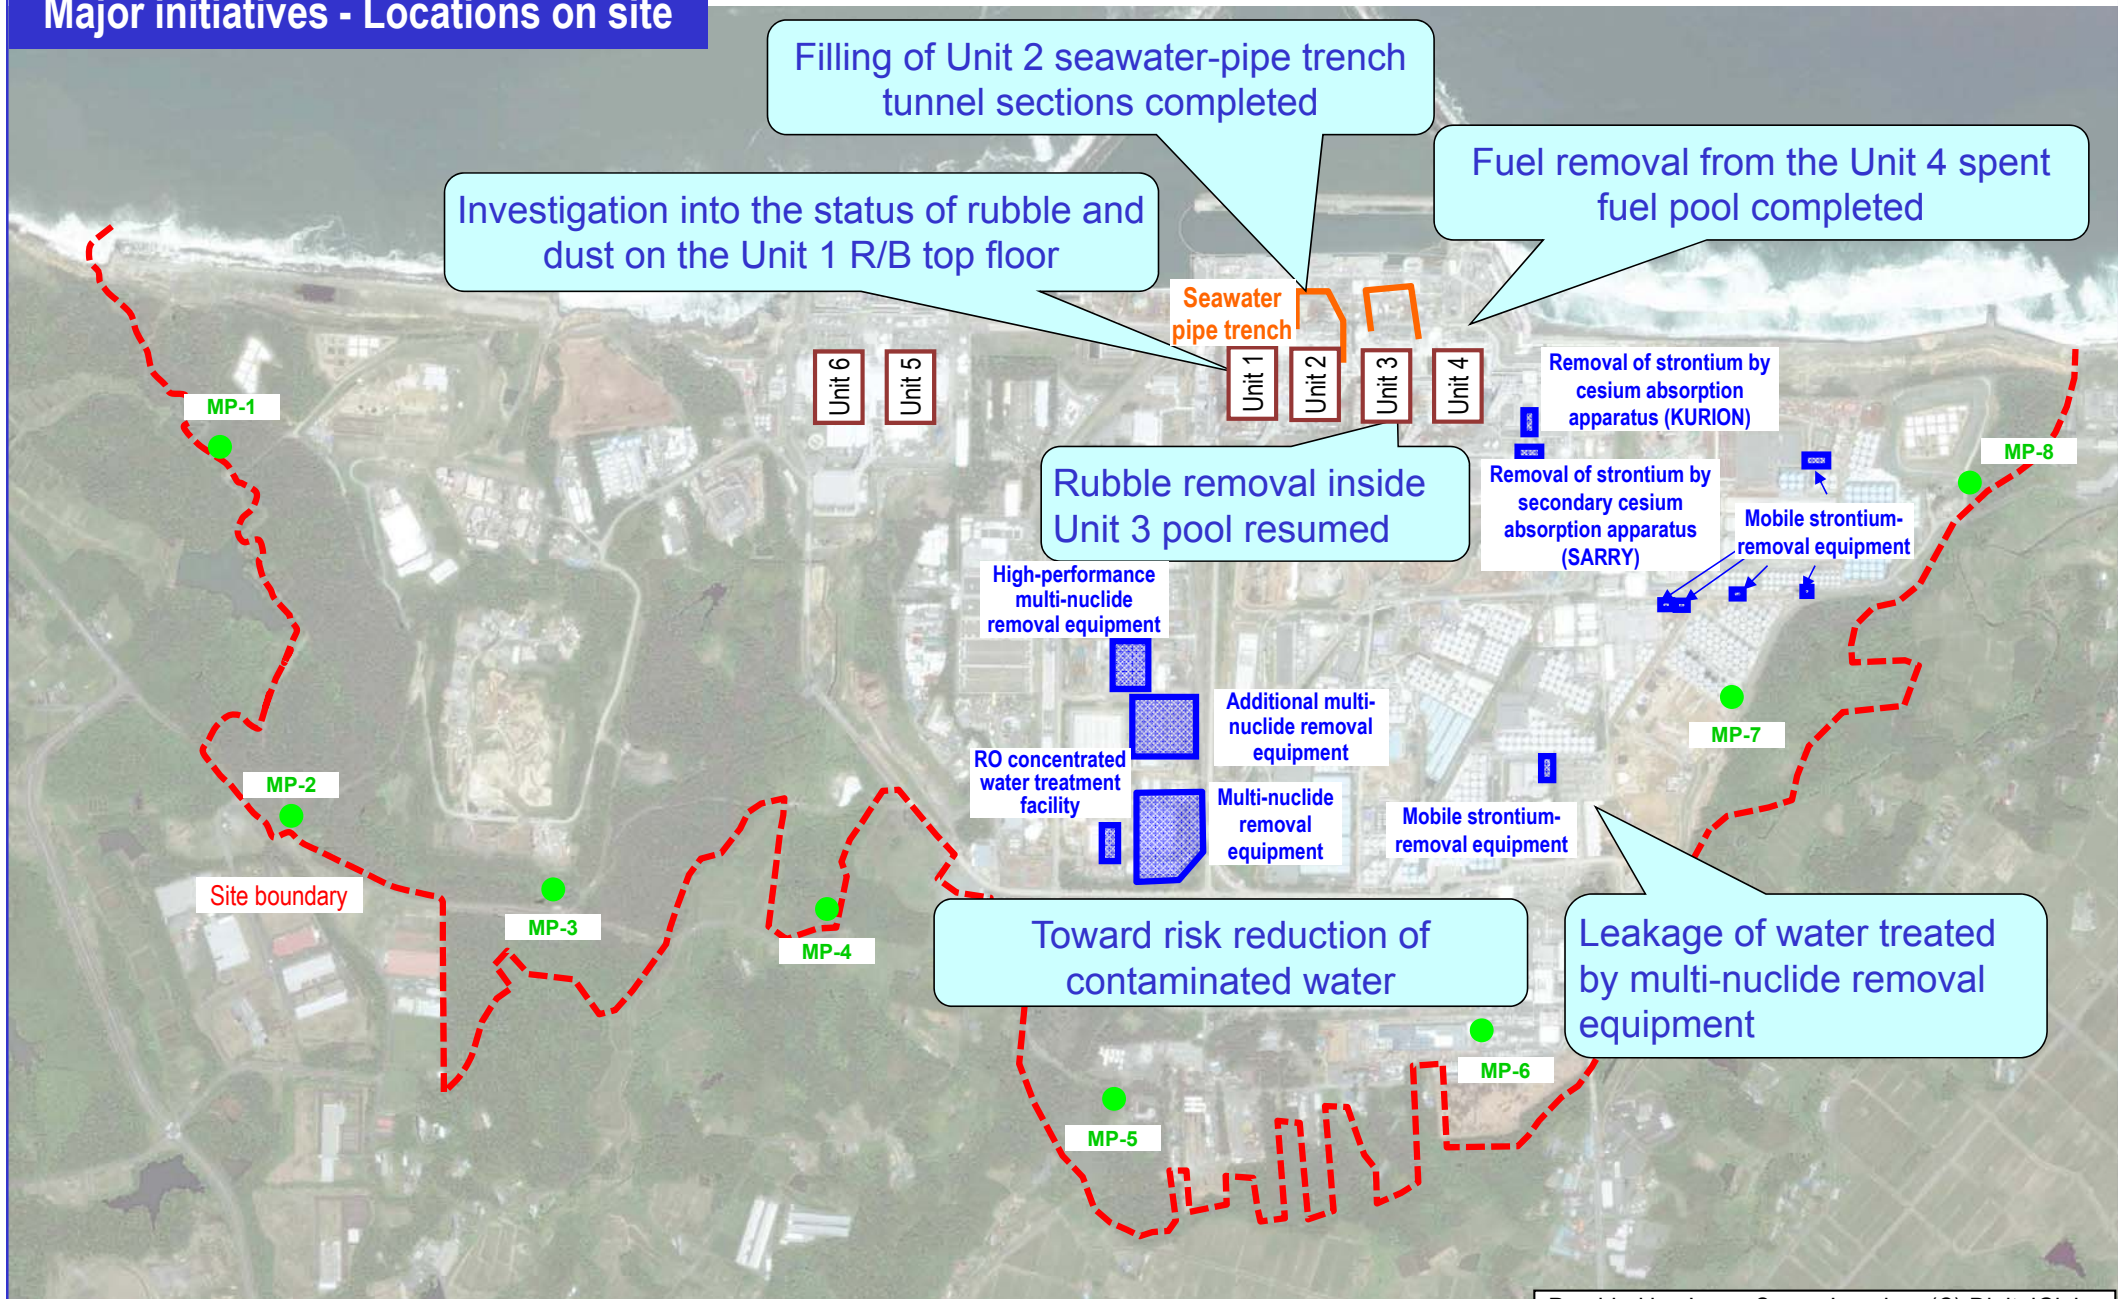
## Major initiatives - Locations on site

\* Data of Monitoring Posts (MP1-MP8.)

Data of Monitoring Posts (MPs) measuring airborne radiation rate around site boundaries show 1.100 - 4.033 $\mu$ Sv/h (November 26 - December 23, 2014.)

We improved the measurement conditions of monitoring posts 2 to 8 for precise measurement of air dose rate. Construction works such as tree-clearing, surface soil removal, and shield wall setting were implemented from Feb 10 to Apr 18, 2012.

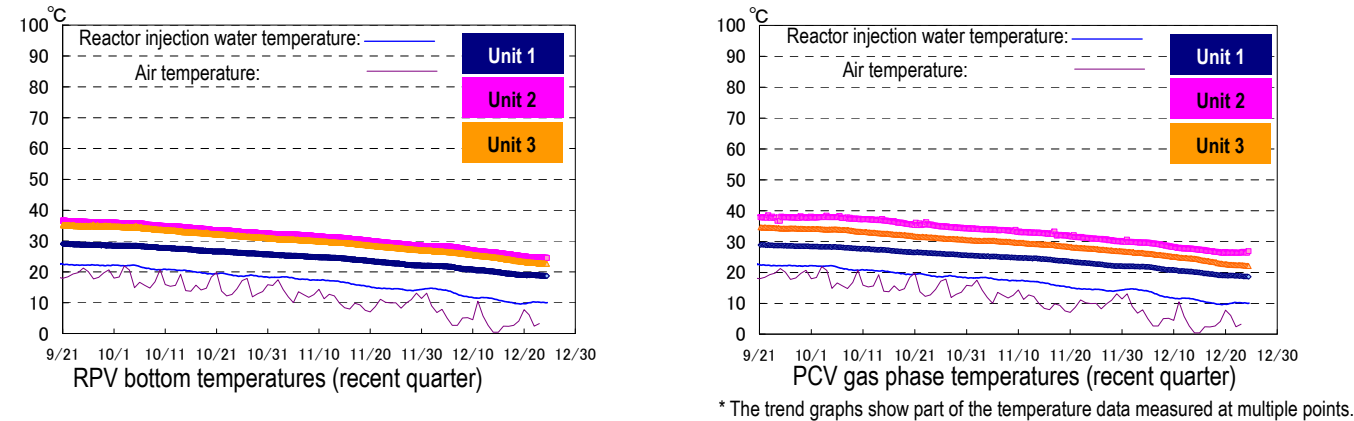
### 1. Temperatures inside the reactors

Through continuous reactor cooling by water injection, the temperatures of the Reactor Pressure Vessel (RPV) bottom and the Primary Containment Vessel (PCV) gas phase have been maintained within the range of approx. 15 to 45°C for the past month, though they vary depending on the unit and location of the thermometer.

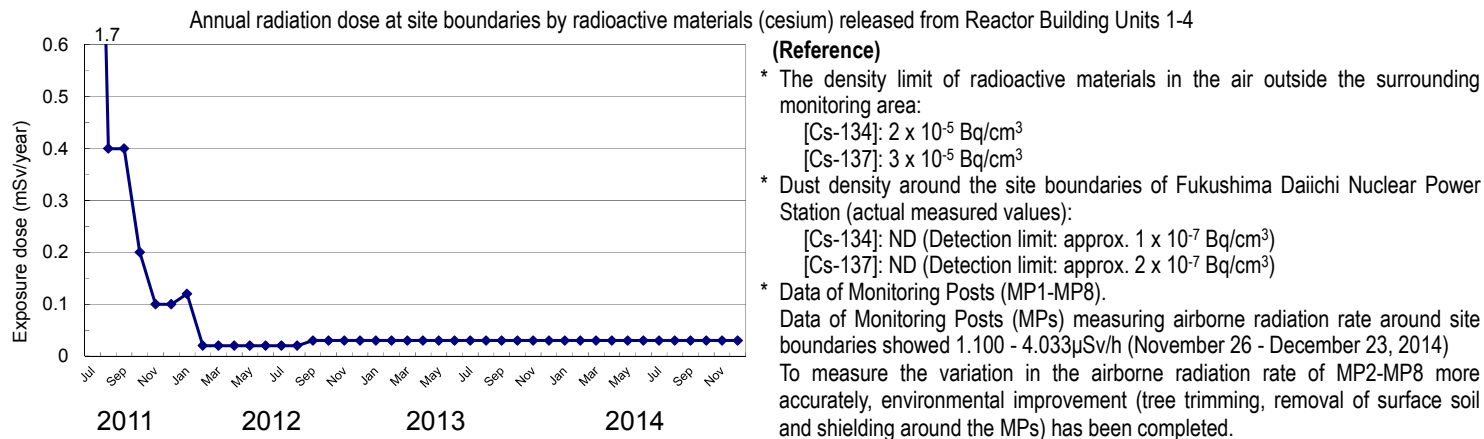
### 2. Release of radioactive materials from the Reactor Buildings

The density of radioactive materials newly released from Reactor Building Units 1-4 in the air measured at site boundaries was evaluated at approx.  $1.4 \times 10^{-9}$  Bq/cm<sup>3</sup> for both Cs-134 and -137. The radiation exposure dose due to the release of radioactive materials was 0.03 mSv/year (equivalent to approx. 1/70 of the annual radiation dose by natural radiation (annual average in Japan: approx. 2.1 mSv/year)) at the site boundaries.

Note: Different formulas and coefficients were used to evaluate the radiation dose in the facility operation plan and monthly report. The evaluation methods were integrated in September 2012. As the fuel removal from the spent fuel pool (SFP) commenced for Unit 4, the radiation exposure dose from Unit 4 was added to the items subject to evaluation since November 2013.

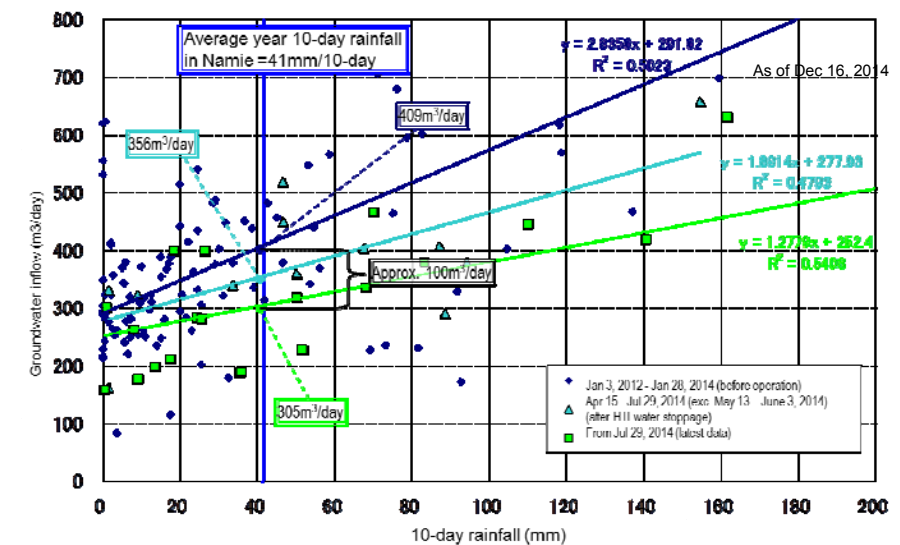
- It was confirmed that the groundwater inflow into the buildings had decreased by 100m<sup>3</sup>/day based on the evaluation data by now through measures such as the groundwater bypass and water stoppage of the High Temperature Incinerator Building (HTI) (see Figure 1).

- It was confirmed that the groundwater level at the observation holes had decreased by approx. 10-15cm compared to the level before pumping at the groundwater bypass started.

Figure 1: Analytical results of inflow into buildings

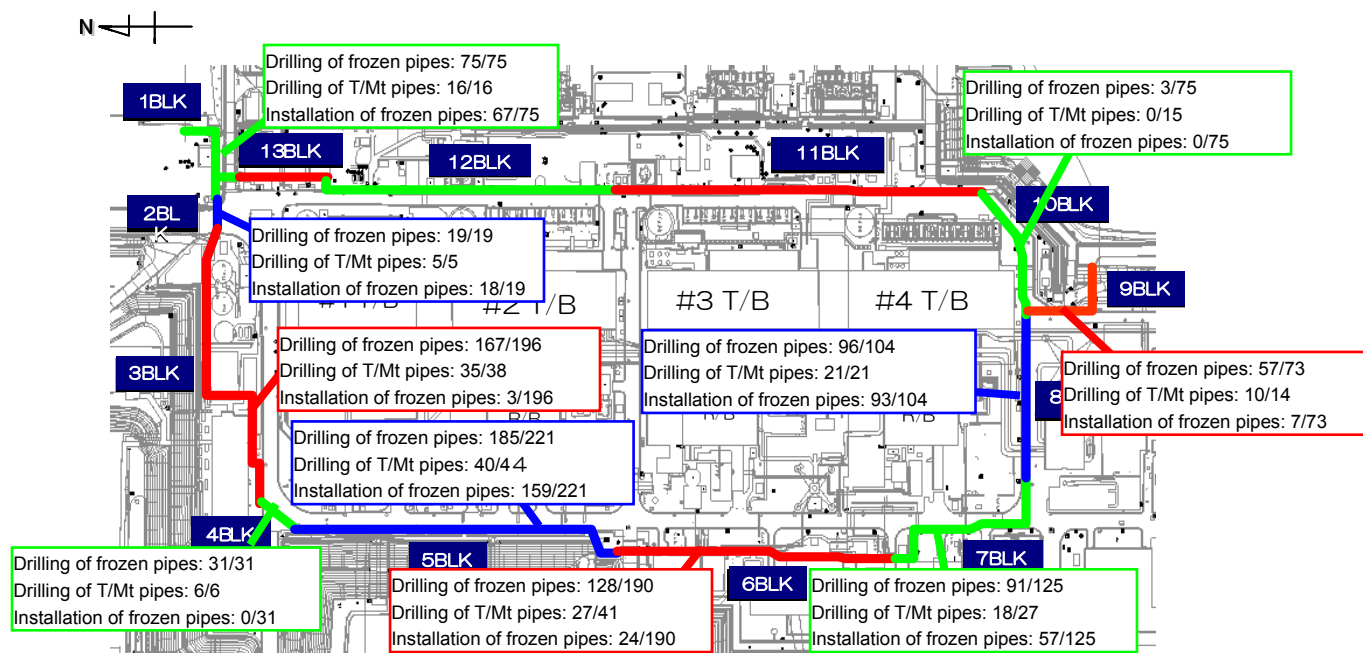
- To facilitate the installation of frozen-soil impermeable walls surrounding Units 1-4 (a subsidy project of the Ministry of Economy, Trade and Industry), drilling to place frozen pipes commenced (from June 2). As of December 24, drilling at 1,030 points (for frozen pipes: 852 of 1,549 points, for temperature-measurement pipes: 178 of 317 points) and installation of frozen pipes at 428 of 1,549 points had been completed (see Figure 2).

Figure 2: Drilling status for frozen-soil impermeable walls and installation of frozen pipes

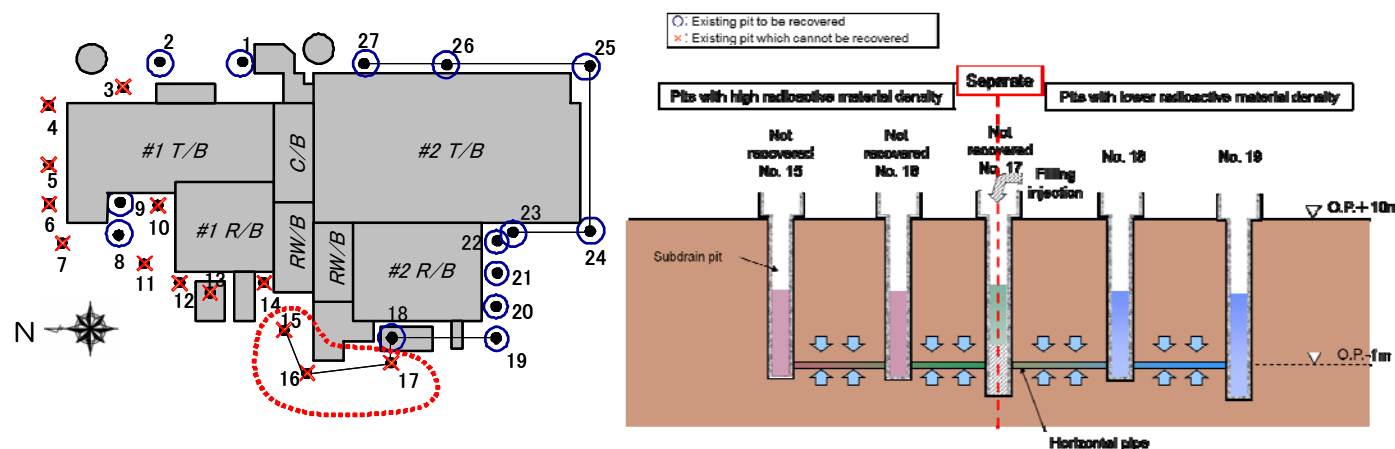
- Though an increase in radioactive material density was detected in subdrain pit Nos. 18 and 19 (October 22), the density drastically declined after this. It was estimated that as those pits connect with pit Nos. 15 to 17, which could not be recovered due to high radiation level, via horizontal pipes, radioactive material was gradually drawn into them by pump operation. Pit No. 17 was blocked with filling material from November 14 to 21, and unrecovered pit Nos. 15 and 16 were separated from recovered pit Nos. 18 and 19. After blocking up pit No. 17, since there was no decrease in the water level of pit No. 17 even when groundwater was drawn from pit Nos. 18 and 19, and since there were no significant changes in radioactive material density in pit Nos. 18 and 19, it was confirmed that separation had been achieved successfully.

Figure 3: Existing subdrain pits around Units 1 and 2

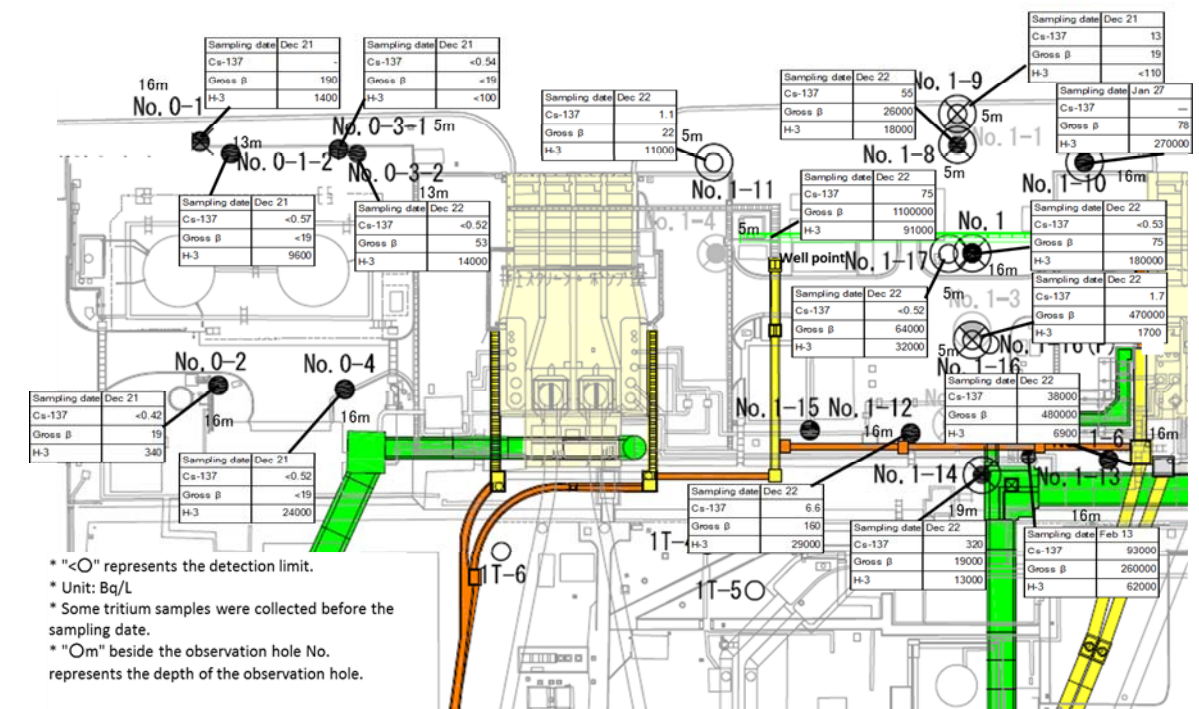
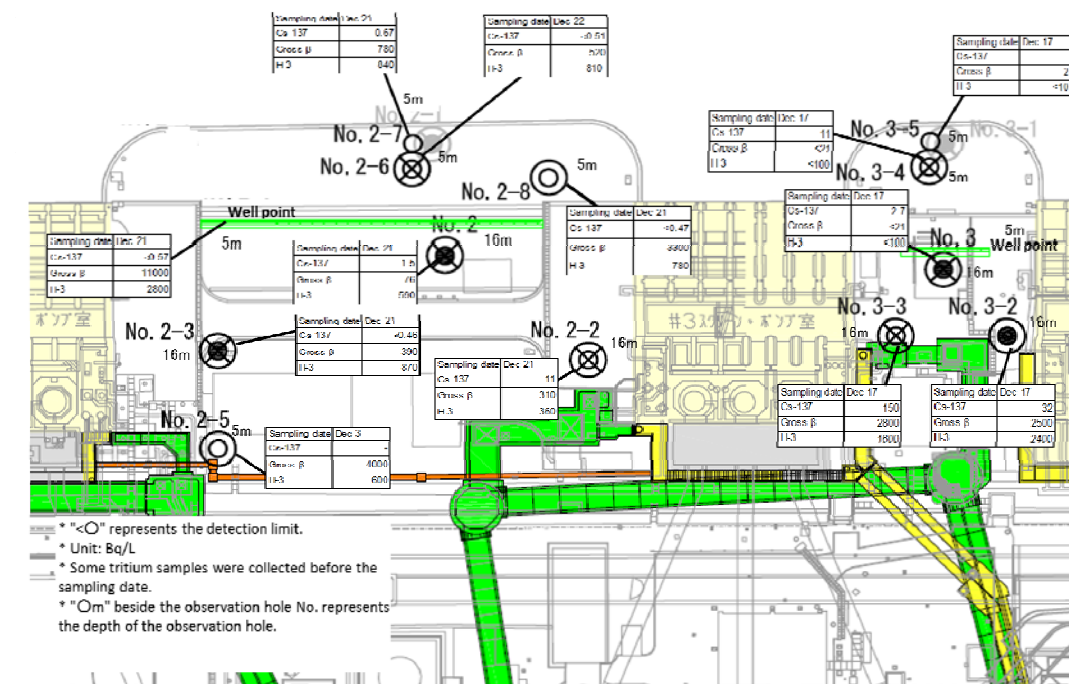
<Unit 1 intake north side, between Unit 1 and 2 intakes>

<Between Unit 2 and 3 intakes, between Unit 3 and 4 intakes>

Figure 5: Groundwater density on the Turbine Building east side

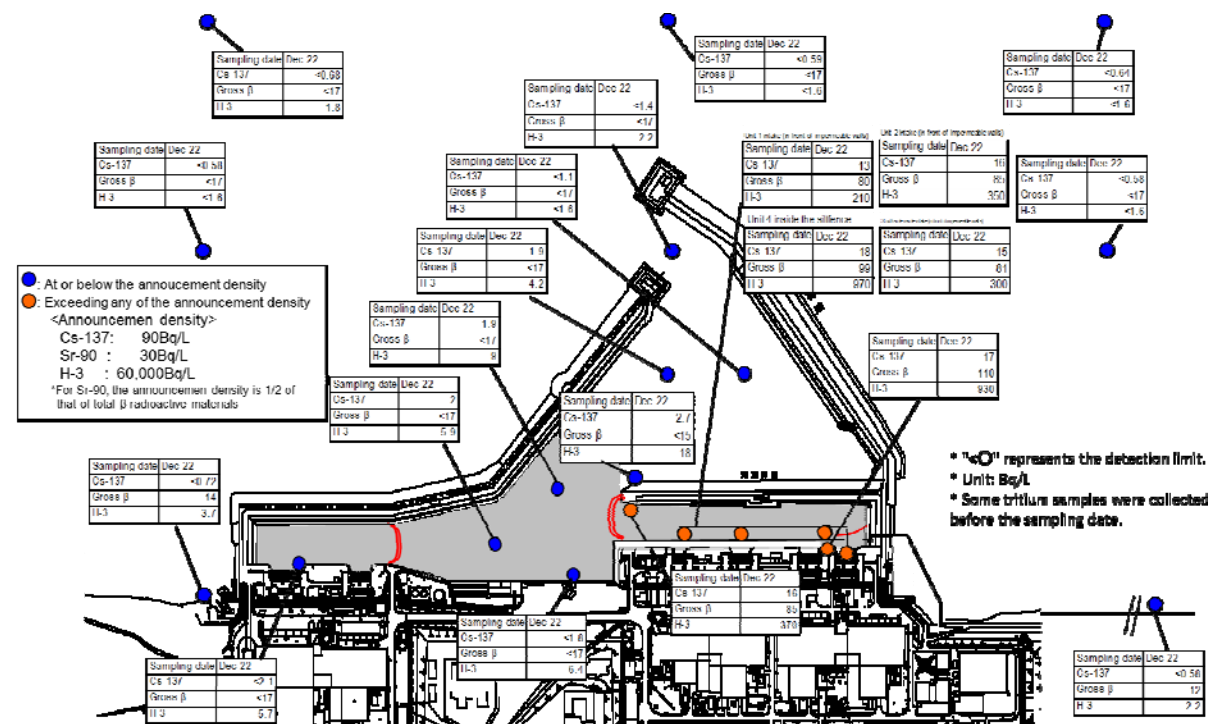
- The density of radioactive materials in seawater within the port has been slowly declining as up to November.
- The radioactive material density in seawater at and outside the port entrance has remained within the same range previously recorded.

Figure 6: Seawater density around the port

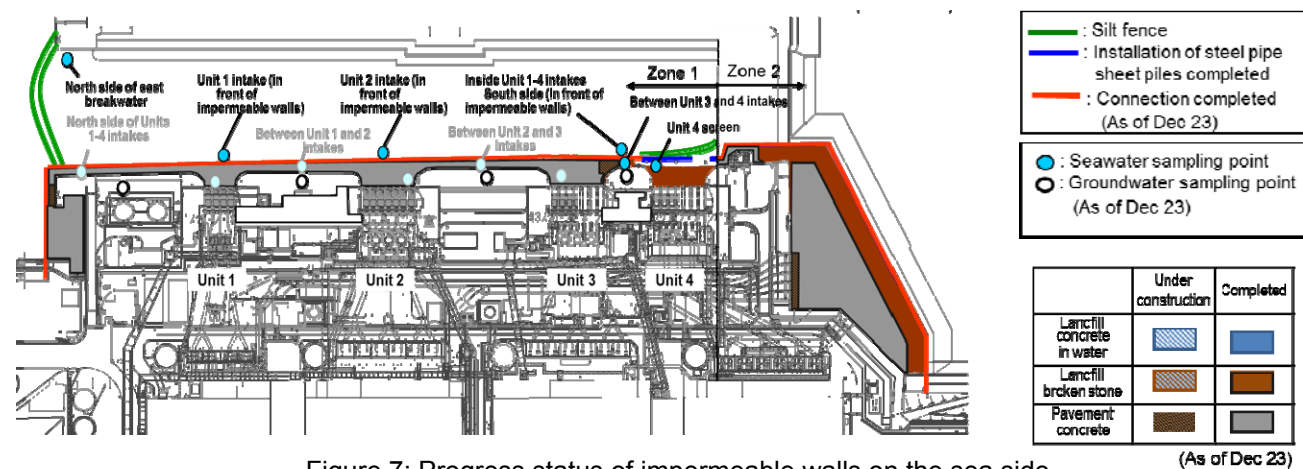
Figure 7: Progress status of impermeable walls on the sea side

- The walls aim to prevent the flow of contaminated groundwater into the sea.
- Installation of steel sheet piles is almost (98%) complete. The closure time is being coordinated.

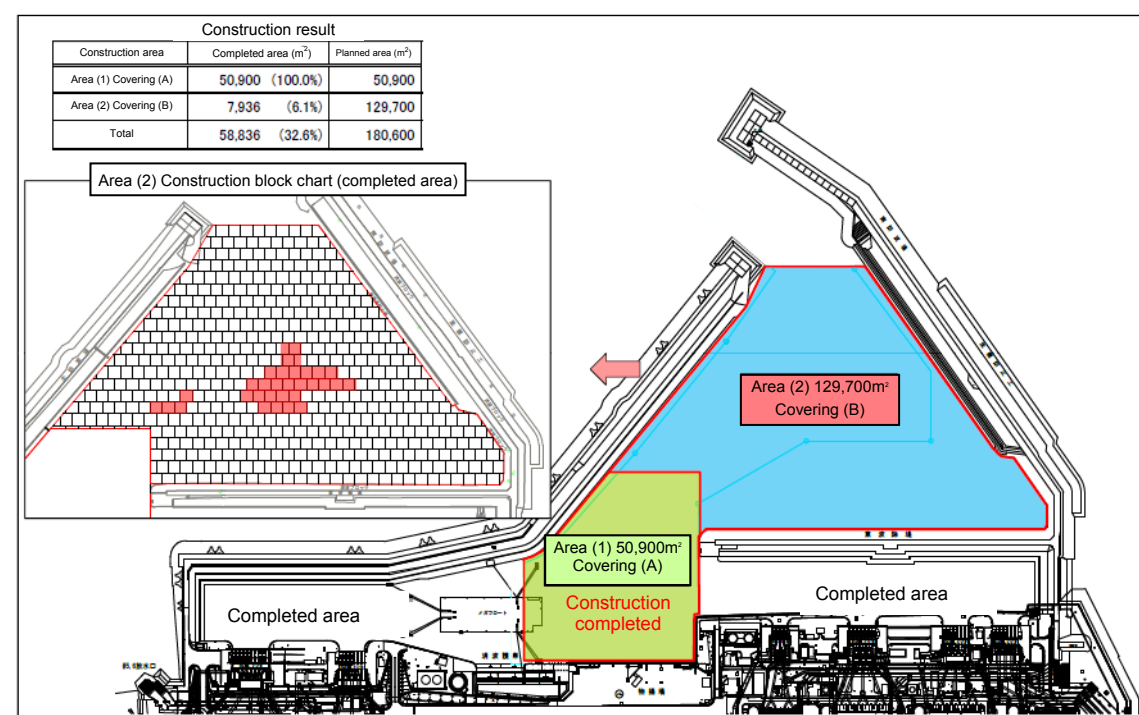
- Construction to cover the seabed soil within the port is underway to prevent contamination spreading due to stirred-up seabed soil (scheduled for completion at the end of FY2014). Modifications to the slurry plant were implemented at the time of the covering work in Area (2). Test construction was carried out from November 17, and since confirmation of the workability and the covering material quality were completed, construction resumed from December 14 (see Figure 8). As of December 23, 33% of the construction had been completed. The seabed of the intake open channels had been covered by FY2012.

Figure 8: Progress status of the seabed soil covering within the port

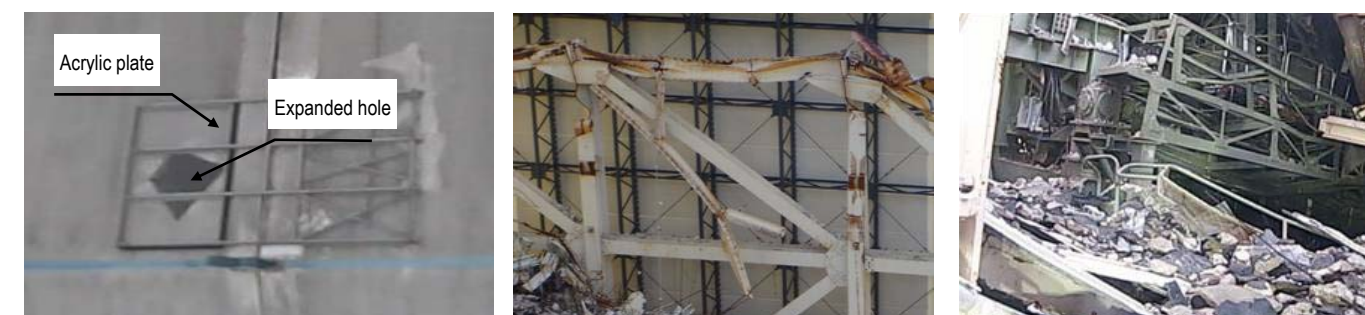
- After removing the two roof panels, the trends of the dust conditions were monitored with regard to the density of radioactive materials in the air, and the results confirmed that due to the effects of the wind, there were no elevations in the concentration of dust.

- In the rubble investigation, confirmation in greater detail was achieved than it could be achieved with balloon investigations and other types of investigations performed in the past. Since it was possible to confirm the status of the rubble to be removed in advance at the upper part of the Reactor Building, the plans for rubble removal will be reviewed. On the underside of the collapsed roof, no conditions such as fallen fuel-handling machines or steel frame materials protruding from the water surface that would cause damage to the spent fuel pool or to the fuel assemblies inside the pool were detected. Further investigations will be conducted after the roof cover has been dismantled.

Figure 9: Upper part of Unit 1 Reactor Building – Covering status of hole in roof panel and status of rubble investigations

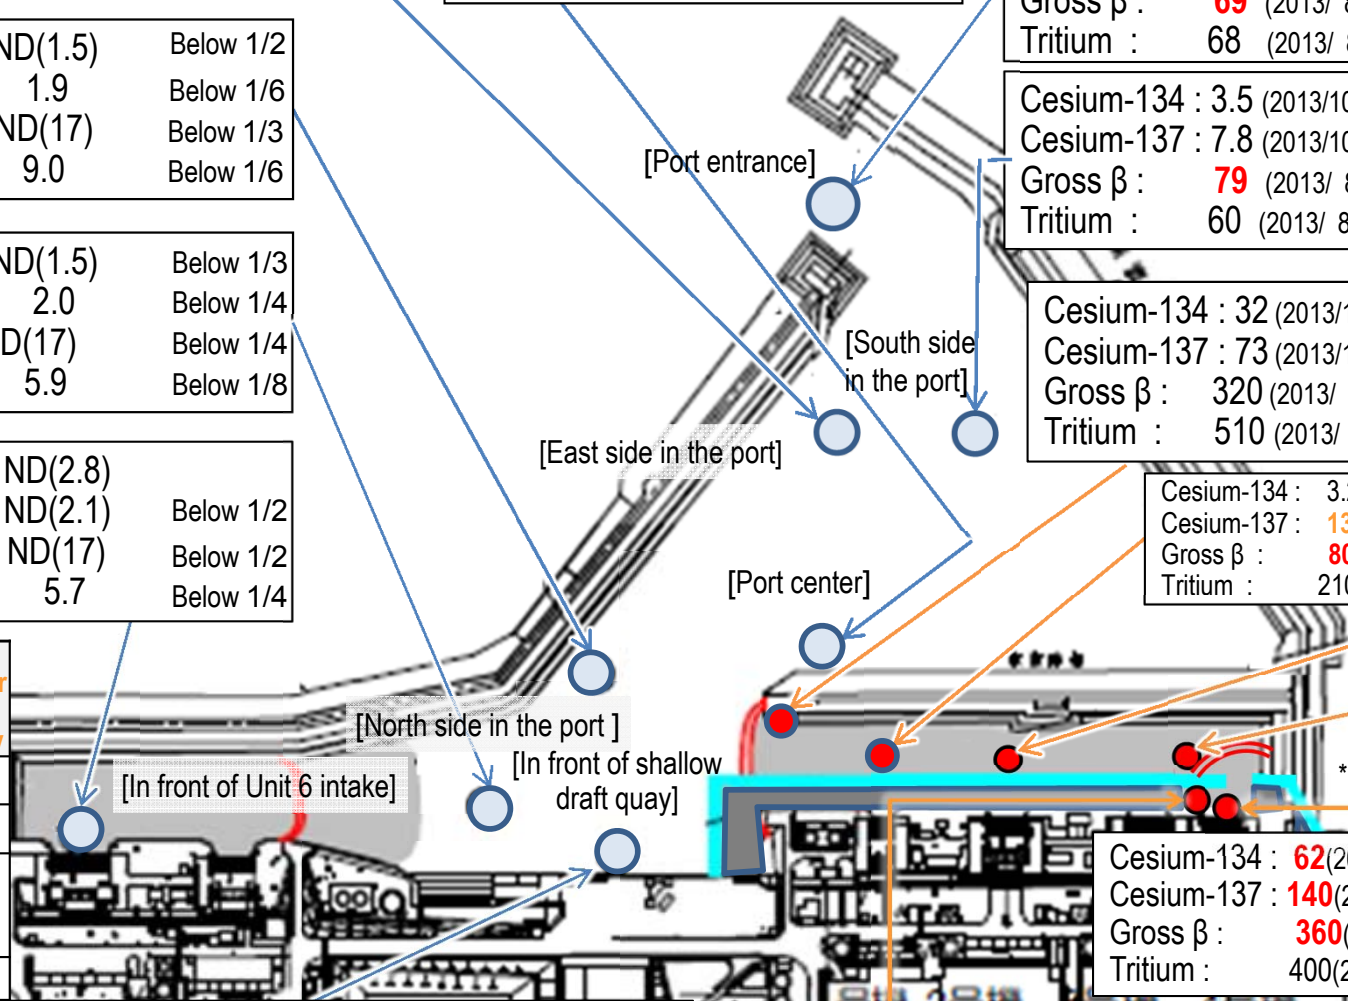
Summary of TEPCO data as of December 24

Note: The gross β measurement values include natural potassium 40 (approx. 12 Bq/L).

(The latest values sampled during December 15-22)

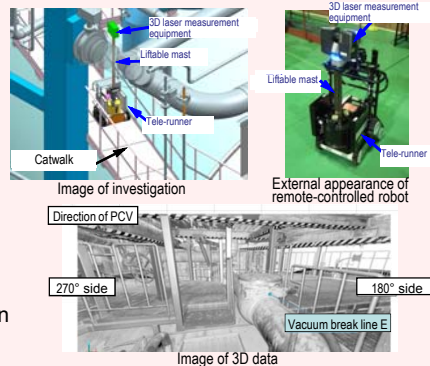
### Investigation in the leak point detected in the upper part of Unit 1 Suppression Chamber (S/C<sup>(\*)</sup>)

Investigation in the leak point detected in the upper part of Unit 1 S/C from May 27 from one expansion joint cover among the lines installed there. As no leakage was identified from other parts, specific methods will be examined to halt the flow of water and repair the PCV.

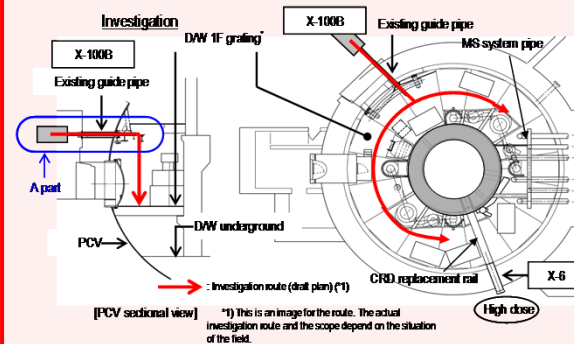
- Crawler-type equipment with a shape-changing structure which allows it to enter the PCV from the narrow access entrance (bore:  $\phi 100\text{mm}$ ) and stably move on the grating is currently under development. A field demonstration is scheduled for the 2<sup>nd</sup> half of FY2014.

Investigative route inside the PCV (draft plan)

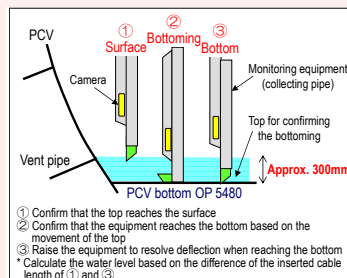
- Some of the permanent supervisory instrumentation for PCV could not be installed in the planned locations due to interference with existing grating (August 13, 2013).
- The instrumentation was removed on May 27, 2014 and new instruments were reinstalled on June 5 and 6. The trend of added instrumentation will be monitored for approx. one month to evaluate its validity.
- The measurement during the installation confirmed that the water level inside the PCV was approx. 300mm from the bottom.

Method to measure water levels when re-installing monitoring instrumentation for Unit 2 PCV

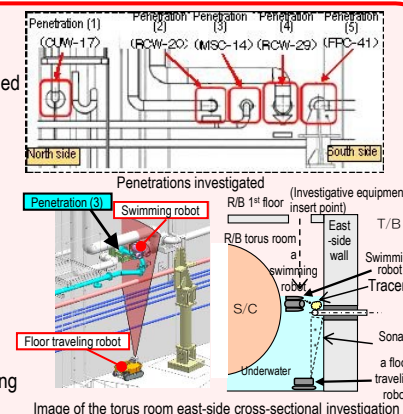
### Investigative results on torus room walls

- The torus room walls were investigated (on the north side of the east-side walls) using equipment specially developed for that purpose (a swimming robot and a floor traveling robot).
- At the east-side wall pipe penetrations (five points), "the status" and "existence of flow" were checked.
- A demonstration using the above two types of underwater wall investigative equipment showed how the equipment could check the status of penetration.
- Regarding Penetrations 1 - 5, the results of checking the sprayed tracer (\*) by camera showed no flow around the penetrations. (investigation by the swimming robot)
- Regarding Penetration 3, a sonar check showed no flow around the penetrations. (investigation by the floor traveling robot)

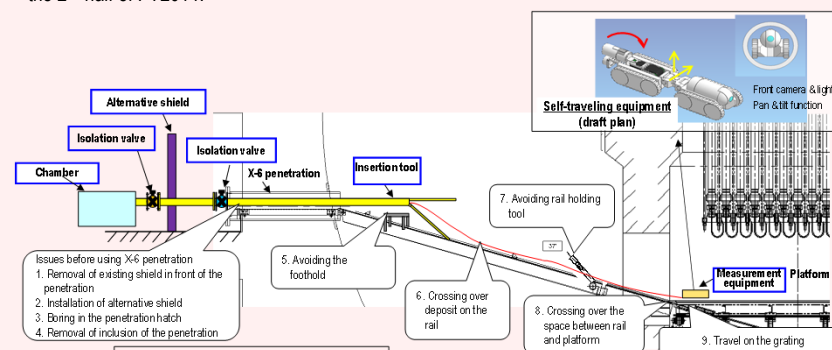
#### [Status of investigative equipment development]

- Based on issues confirmed by the CRD rail status investigation conducted in August 2013, the investigation method and equipment design are currently being examined. A demonstration is scheduled in the field in the 2nd half of FY2014.

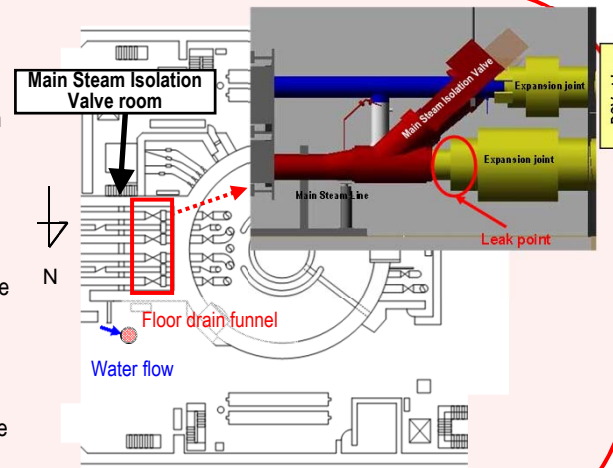
From April 23, image data has been acquired by camera and the radiation dose measured via pipes for measurement instrumentation, which connect the air-conditioning room on the Reactor Building 2nd floor with the Main Steam Isolation Valve Room on the 1st floor. On May 15, water flow from the expansion joint of one Main Steam Line was detected.

This is the first leak from PCV detected in Unit 3. Based on the images collected in this investigation, the leak volume will be estimated and the need for additional investigations will be examined. The investigative results will also be utilized to examine water stoppage and PCV repair methods.

Outline of the water-flow status

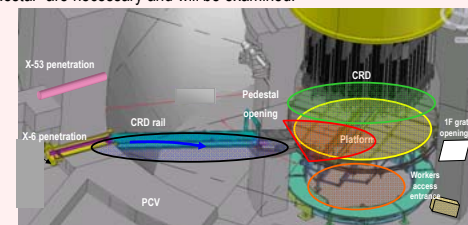
-Based on the measurement values of hydraulic head pressure inside the PCV, X-6 penetration may decline. It is estimated that access to X-6 penetration is difficult.

-For access from another penetration, approaches such as "further downsizing the equipment" or "moving in water to access the pedestal" are necessary and will be examined.

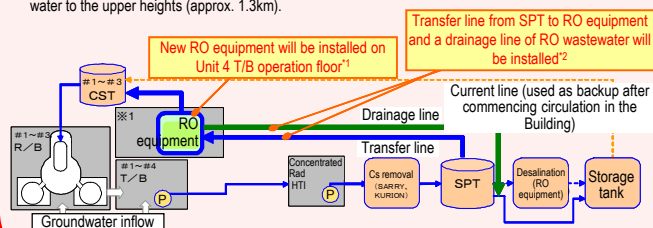
- Operation of the reactor water injection system using Unit 3 CST as a water source commenced (from July 5, 2013). Compared to the previous systems, in addition to the shortened outdoor line, the reliability of the reactor water injection system was enhanced, e.g. by increasing the amount of water-source storage and enhancing durability.
- By newly installing RO equipment inside the Reactor Building by the first half of FY2015, the reactor water injection loop (circulation loop) will be shortened from approx. 3km to approx. 0.8km\*.
- \* The entire length of contaminated water transfer pipes is approx. 2.1km, including the transfer line of surplus water to the upper heights (approx. 1.3km).

\*1 Unit 4 T/B operation floor is one of the installation proposals, which will be determined after further examination based on the work environment  
\*2 A detailed line configuration will be determined after further examination

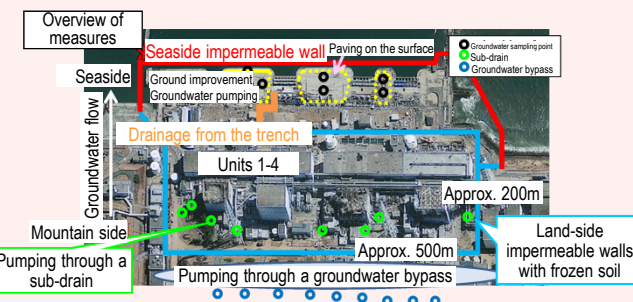
- (3) Eliminate contamination sources
    - Removing contaminated water in branch trenches and closing them (completed on September 19, 2013)
    - Removal of contaminated water in the seawater pipe trench

- Unit 2: November 25, 2014 to December 18, 2014 - filling of tunnel sections with cement-based materials.
      - Unit 3: Drilling of holes to install frozen/ temperature-measurement pipes is completed.
