## **Events and highlights on the progress related to recovery operations at Fukushima Daiichi Nuclear Power Station**

**March, 2018**

**(corrected June, 2018)**

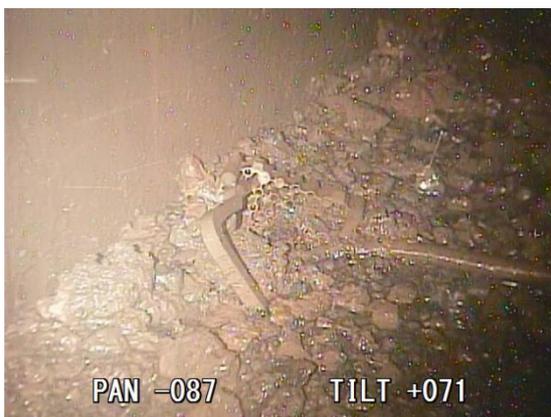
Bottom of the pedestal

As a result of the investigation, it was confirmed that there was falling of a part of the fuel assembly to the bottom of the pedestal, so it was estimated that deposits confirmed around it are fuel debris. In the future, the acquired images will be analysed.

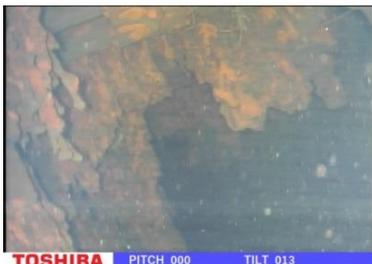
bottom of CRD housing

For Unit 3, It was succeeded for the first time after the accident to acquire image inside of pedestal using underwater ROV from 19 to 22 July 2017. As a result, in the pedestal, considered to be solidified molten materials and damage situation of some structure such as housing support and grating were confirmed. In November 2017, analysis of image data obtained in the investigation was released. It identified damage to multiple structures and the supposed core internals. Consideration of fuel debris retrieval based on the obtained information will continue.

For Unit 3, analysis of image data obtained in the July 2017 investigation was released in November 2017. Damage to multiple structures and the supposed core internals was identified.

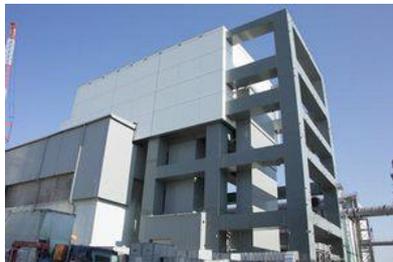
Equipment for fuel removal

In spite of a hydrogen explosion, the fuel assemblies of Unit 4 were not damaged, as the plant was in cold shutdown status and all the fuel had been stored in the spent fuel pool before the accident. The fuel assemblies in the pool were taken out and transferred to the common pool located within the station site. This fuel removal operation started on November 2013 and was safely completed in December 2014. Fully utilizing this successful experience, the fuel assemblies remaining in the spent fuel pools of Units 1, 2 and 3 will be removed.
